RELIABILITY OF NON-HERMETIC OPTICAL TRANSCEIVERS

Final Presentation

ESA No. 4000133320/20/NL/FE

17th December 2024

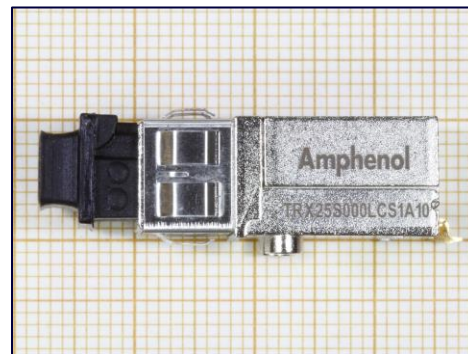
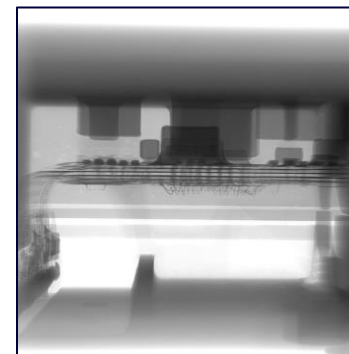
- Device construction is based on multi-layer PCB, flex-PCB and SMT technology.
- X ray revealed apparently wire crossing each other. Visual inspection showed they were acceptable since they were located within the same connection pad.
- Good internal structure was observed. No foreign particles, broken or damaged dice, scratches in the metallizations or any other deviations were observed.
- Wire pull and die shear tests were successful on all wires of two samples.

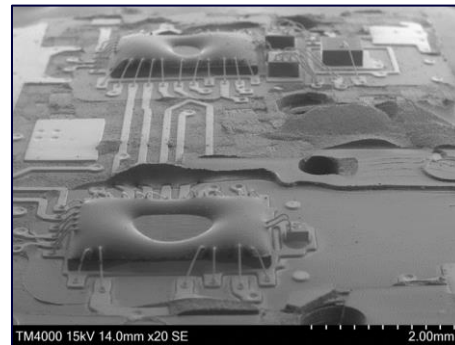
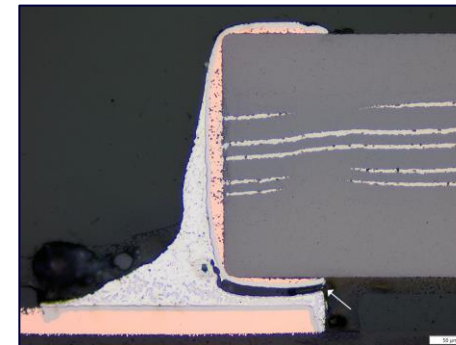
- SEM inspection of the internal construction was performed with successful results.
- Pure tin was first identified at the surface of the solder joints (under a conformal coating). However, during the cross-section, the bulk material of the solder joint was found to be SAC.
- Different planes were inspected during microsection analysis. A void in the solder joint of a capacitor was found, exceeding the acceptable limit of ECSS-Q-ST-70-61C standard.

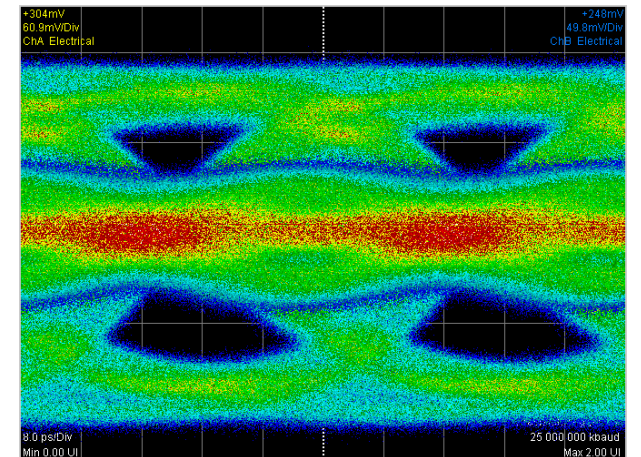
- Testing in this subgroup includes thermal cycling, mechanical shock, vibration test, and final extended thermal cycling. Additionally, cold start at -35°C was performed before and after each thermal cycling.
- Four samples passed all the test flow successfully.
- One sample showed no output in one of the differential signals after vibration test. Failure was identified on RX side testing it using a different device as transmitter.
- One sample failed during the final extended thermal cycling. A reduction was observed in the eye height after the first 100 cycles. After 200 cycles the samples was not functional and showed much lower current consumption than expected (approx. 60 mA lower than usual).
- Both samples were opened and inspected but no root cause could be found.

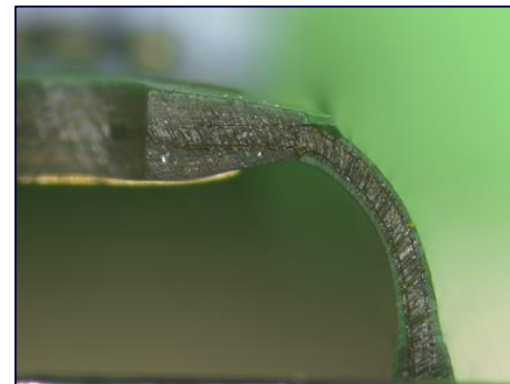
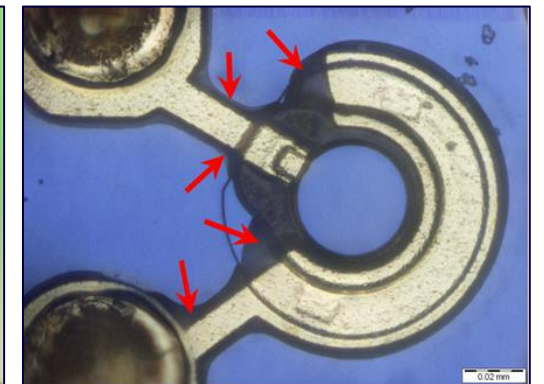
- Testing in this subgroup includes temperature humidity test and thermal vacuum cycling, and cold start at -35°C before and after each test.
- Three samples passed all tests. However, the three remaining failed humidity test. The samples were not functional and could not be measured.
- One of the samples was further inspected. It showed a low Tx power warning alarm in the SW, and the current consumption was much lower than expected. Tx and Rx side were tested separately and none of them worked.
- Sample was opened for inspection, revealing:
 - A crack in the flexiboard affecting only the soldermask.
 - Residual moisture on Rx side.

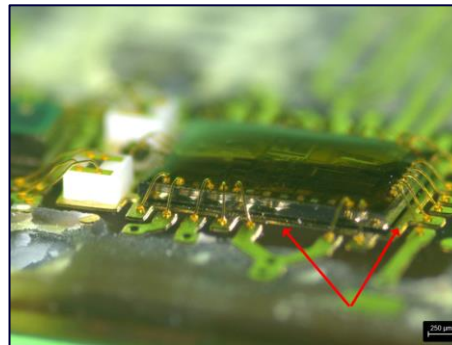
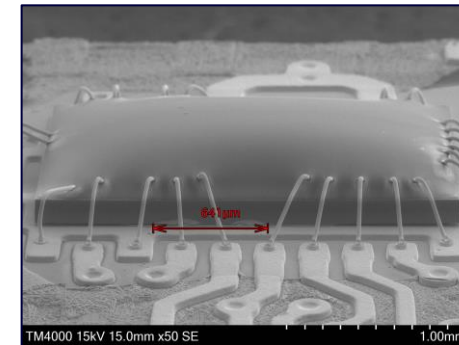
- Internal visual inspection showed non-acceptable lack of die attach (on IC6 VCSEL driver, IC7 TIA, and D2 monitoring diode) on three samples. Die attach medium is Ag 100%.
- The anomalies were also verified during SEM inspection on the three opened samples.
- Die shear test failed on IC6 (on all three samples), IC7 (on two samples) and R12 (on one sample).

- These are COTS components that are not subjected to space requirement inspections. It would be **advisable for Amphenol to review the manufacturing processes** in order to avoid these fabrication defects.

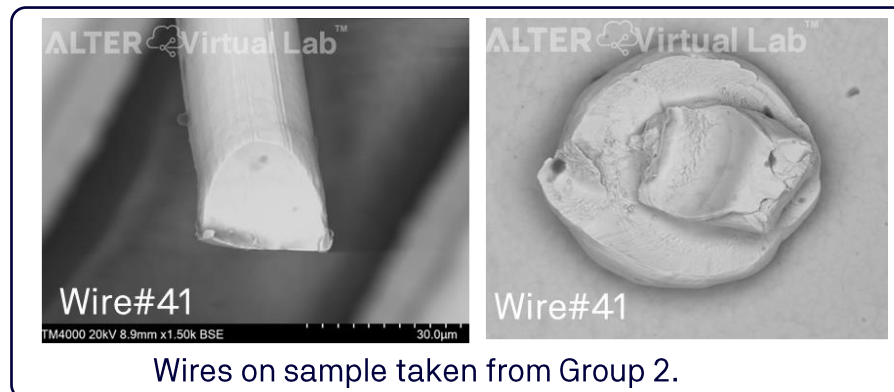
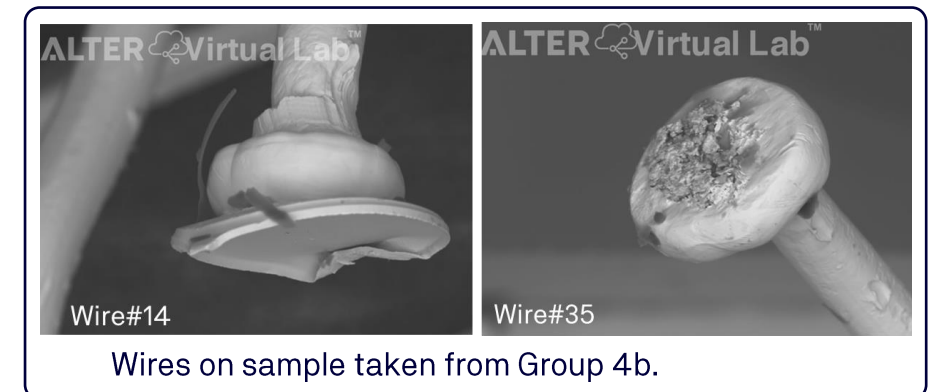
- Two samples failed wire pull test, two wires on each sample. SEM inspection was performed on the failed wires after the test.
- Different breaking modes were observed: at neckdown point and at the bonding pads.
- Sample from Group 4b was the one failing after humidity test. It should be highlighted that wire #14 is the one connecting VCSEL driver and VCSEL, while wire #35 bonds the monitoring diode D2. Wire #14 was lifted from VCSEL, and wire #35 from D2. This deviation may be linked to the observed functional failure showing a low Tx power warning alarm.

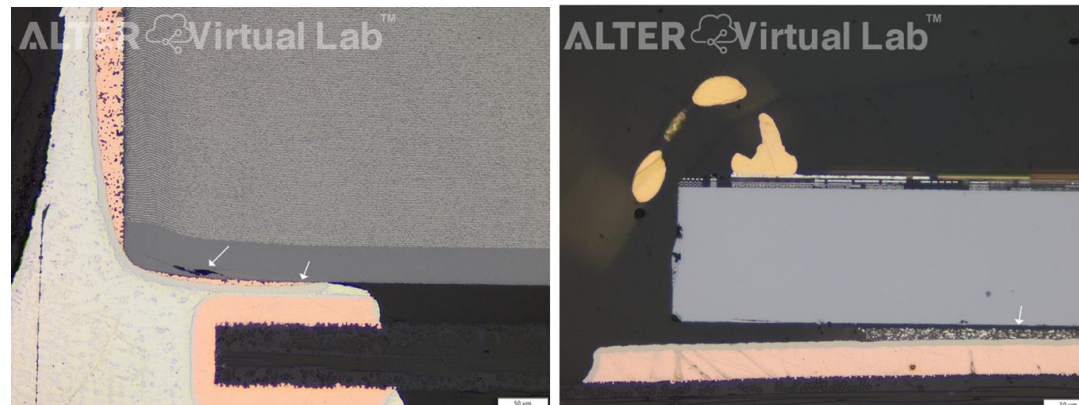
- Remaining three samples were used for microsection analysis and material analysis.
- Microsection analysis on the sample taken from Group 4a revealed:
 - Non-acceptable crack in the ceramic of the component C11
 - Non-acceptable separation of adhesive from the contact surface of component IC7 (TIA).
- All the internal elements showed no prohibited or foreign materials.

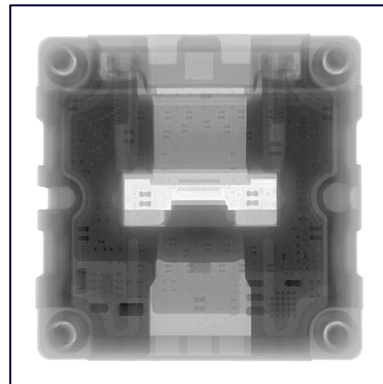
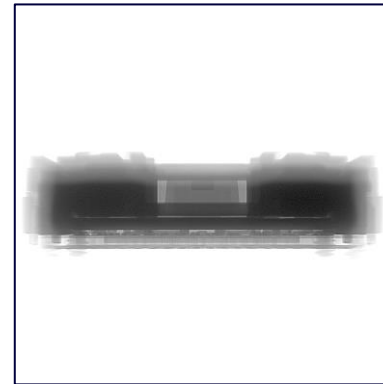
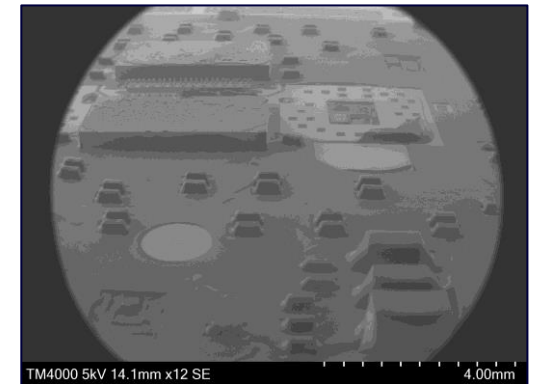
- Constructional analysis showed a construction based on multilayer PCB and SMT technology but not as complex as SCFF.
- X-ray inspection revealed the same internal structure on all samples and no anomalies.
- Good internal structure was observed once opened, although some elements were detached during opening.

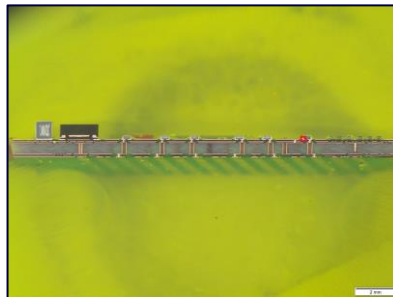
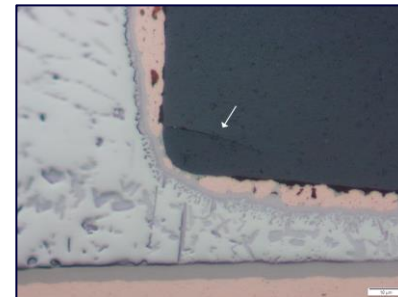
- Wire pull and die shear tests were successful.
- X-ray inspection was carried out on an opened sample to help determine the PCB stack-up and select planes for microsection analysis.
- Material analysis of the surface of solder joints revealed pure tin (Sn 100%), which was covered by conformal coating.
- Microsection analysis revealed a non-acceptable crack according to the standard ECSS-Q-ST-70-61C, Table 14-6, in the ceramic body of C10 capacitor.
- Material analysis showed no prohibited or foreign materials. In fact, composition of the bulk solder material was detected to be SAC.

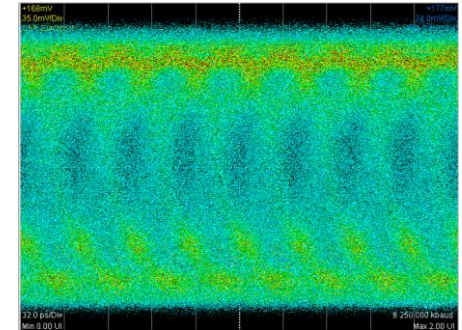
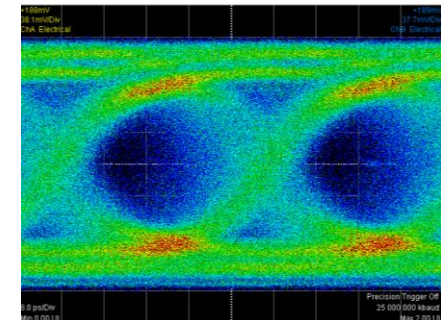
- Testing in this subgroup includes temperature humidity test and thermal vacuum cycling, and cold start at -35°C before and after each test.
- Four samples passed all the tests successfully.
- One sample showed deviations in its performance in one channel during humidity test. First showing measurable BER values below the limit (after 250h), then failing to pass the BER parameter limit (after 500h), and finally stopped working (after 750h). Same result was obtained for the Tx side and for the sample in loopback configuration. No anomaly was found after opening the sample.
- One last sample failed to pass E/O characterization after thermal vacuum test. No BER or eye diagram could be measured in one of its channels. This sample was chosen to be used for final DPA, but no deviations were observed.

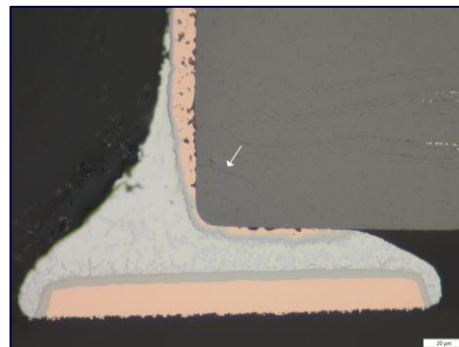
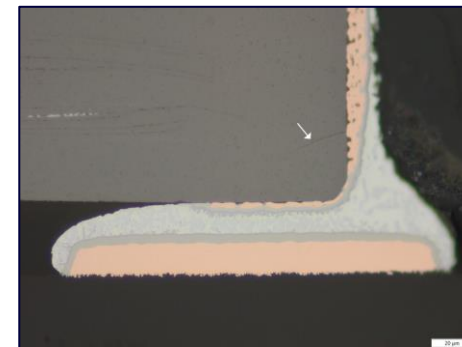
- During final DPA, all tests but the microsection were successful.
- Microsection revealed a non-acceptable crack in the ceramic body of capacitor C10, on one sample taken from Group 4a. That is, the same deviation that was found during constructional analysis.
 - This deviation seems to be related to the capacitor itself or its mounting process, and not to the applied stress.

- This device shows **good internal construction**, with the only defect found in a capacitor. This defect was also observed in a sample inspected during the final DPA. The placement of the **crack** at the area of the cover plates of the capacitor and the fact that the crack was detected during the reference constructional analysis, leads to the **hypothesis of an issue related to the component itself and not the applied stress**.

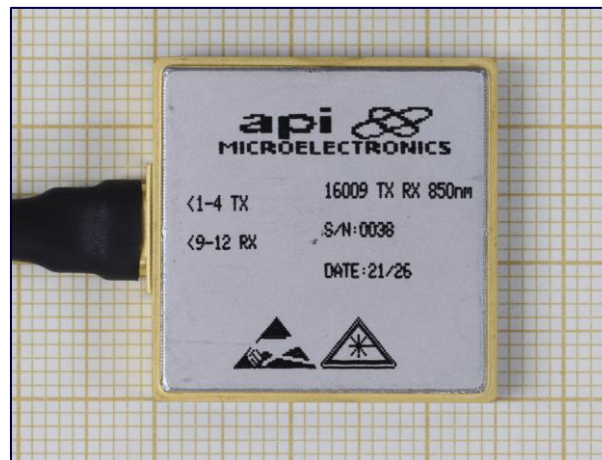
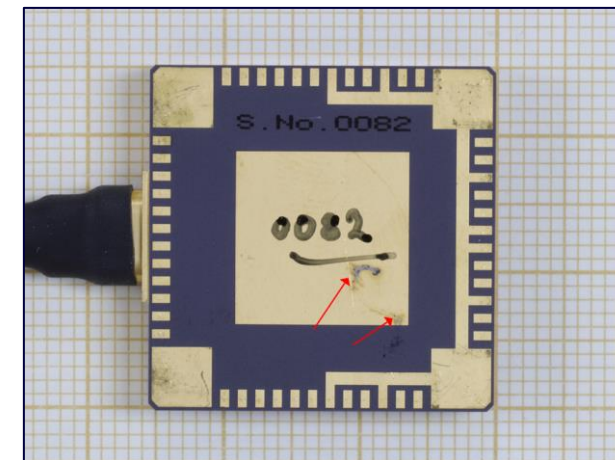
- Delivery of the samples was performed in seven different batches along seven months.
- During the visual inspection, two samples are rejected due to the presence of foreign material in pads.
- All samples show evidence of manipulation (scratches, fingerprints) and socket marks that are considered cosmetic defects.

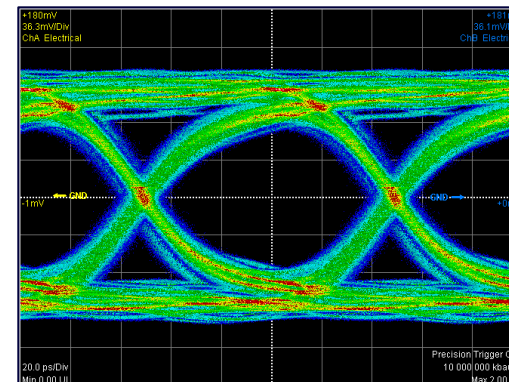
Eye diagram on Rx side

- Repeatability tests were performed on several samples, and it was found that some samples showed no communication error (BER < 10^{-12}), while some others were much more sensitive and not that repeatable.
- It was observed that those showing communication errors were sensitive to the position and movement of the fiber attached on the sample.
- Additionally, since Tx and Rx sides were tested separately, it could be observed that eye diagram on Rx side was closer than Tx side.

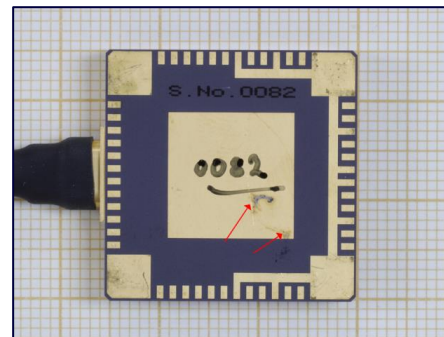
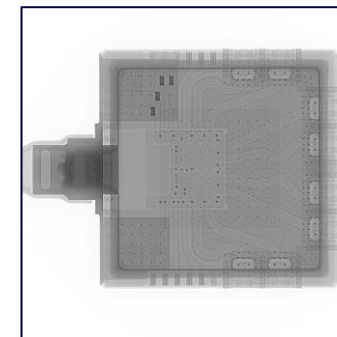
- One sample showing foreign material was chosen, so this deviation was again reported at initial external visual inspection.
- The device shows a very different construction compared to previous devices, based on ceramic packaging, alumina and a much lower component count on the assembly.
- X-ray inspection showed same internal structure for dice location and wires clearance.
- Fiber pull test was also carried out satisfactorily.

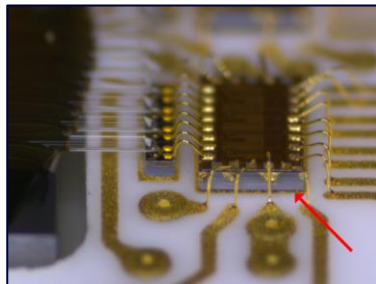
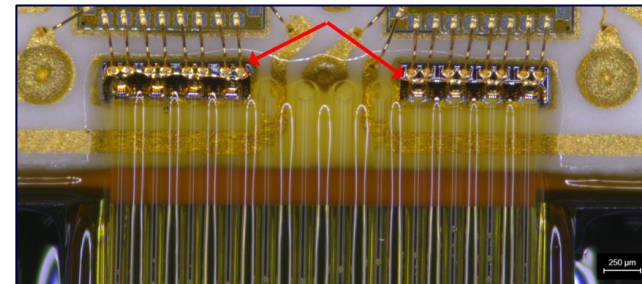
- In the internal visual inspection, samples showed a lack of die attach on the assembled dice.
- In addition, the material used for fixing the optical fiber has different coverage in different samples. In some of them, the material covers TX and RX diodes.
- SEM inspection, confirmed the previously observed anomalies of lack of die attach and material excess covering TX and RX diodes.

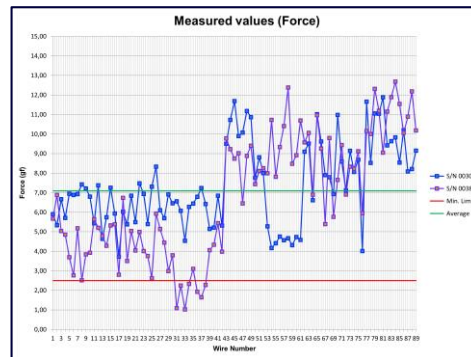
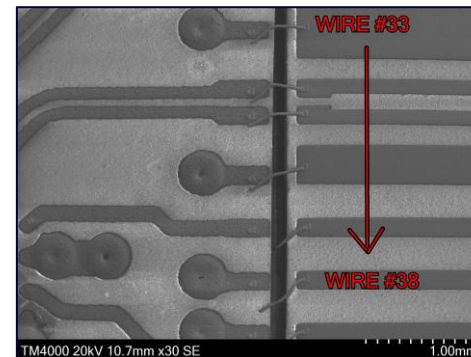
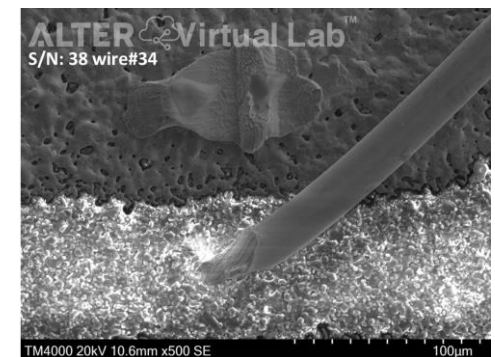
- All the wires of one sample passed wire pull test, while seven wires failed in the second sample. The failure occurred at neckdown point.
- SEM inspection did not reveal any anomaly on the failed wires. No differences were observed either between the wires that passed the test and the ones that failed.
- Both samples passed die shear test on all elements.

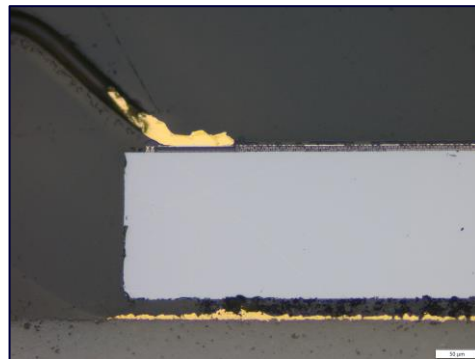
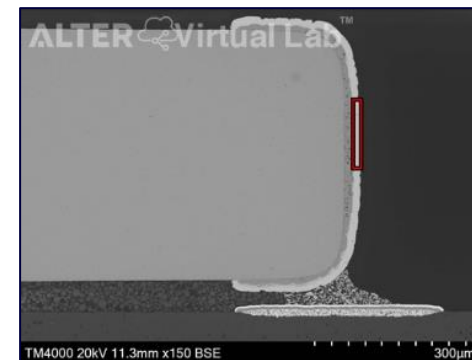
- One sample was cross sectioned at package level. No issues were detected.
- Material inspection revealed pure tin in the capacitors contact finish.
- Other internal elements showed material composition in line with the expected for this kind of device. Metallizations have ENIG finish, and silver is detected on solder joints of passive elements.

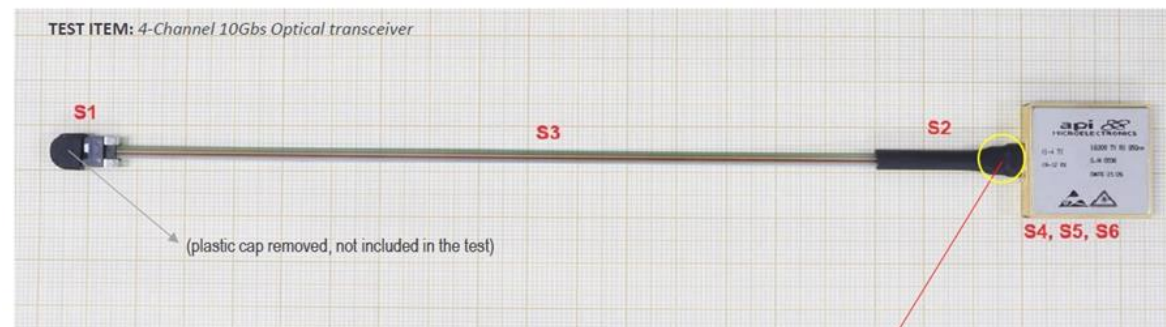
- For outgassing test, one sample was divided into six different items to be tested separately. Samples from CA were used to complement the required weight for some of the items.
- Items S4, S5, and S6 passed the outgassing test according to all criteria (TML, RML, CVCM).
- Items S1, S2, and S3 passed the test according to TML and RML, but failed according CVCM criteria.

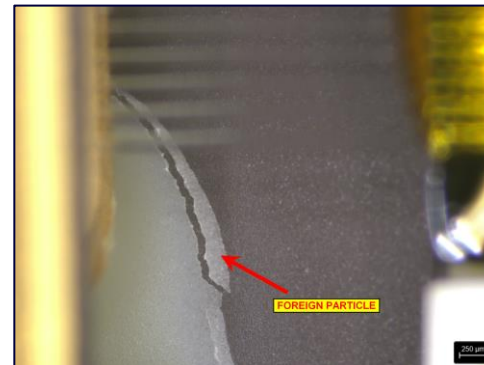
- ESD test was carried out at a single voltage level of 2 kV following test method 3015 of MIL-STD-883 Electrostatic Discharge Sensitivity Test Method.
- Two channels of the sample failed the following E/O characterization. In one channel the eye diagram could get some signal, but no synchronization was possible. The second channel showed no live signal.
- Sample was inspected using X-ray with no deviation observed. PIND detected some loose particle which was later identified during internal visual inspection as part of the connector's glue.

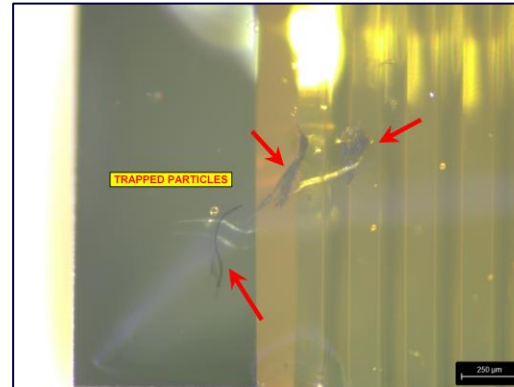
- Trapped foreign material is also observed trapped in the glue to used to fix the fiber optics.
- None of these deviations seem to be related to the defective behaviour.

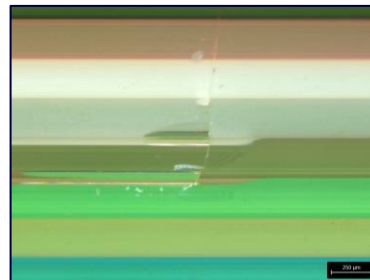
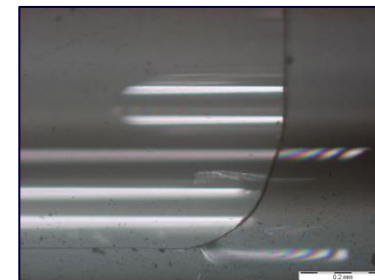
- Testing in this subgroup includes temperature humidity test and thermal vacuum cycling, and cold start at -35°C before and after each test.
- Five samples passed all the tests successfully, although three showed random communication errors with BER values below 10^{-9} .
- One last sample failed E/O characterization in one channel after thermal vacuum test. A crack was detected at the fiber optics which seems to be caused by mishandling during thermal vacuum test.
- It cannot be determined if the crack affects the fiber or only the coating. However, it occurs at the exact channel failing the E/O test.

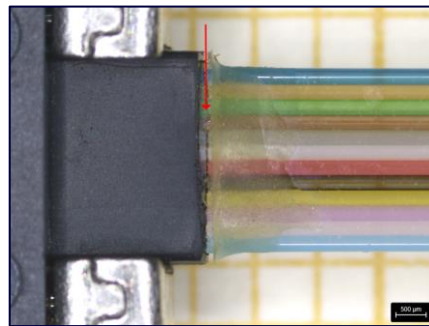
- One sample taken from Group 4a showed a crack onto the sleeve of the fiber located at the input of the MT-Ferrule connector.
- Radiographic inspection and fiber pull tests were successful on all tested samples.
- During internal visual inspection, all samples showed a lack of die attach on the assembled dice. In addition, an excess of the material fixing the optical fiber was also observed in only one of the samples.

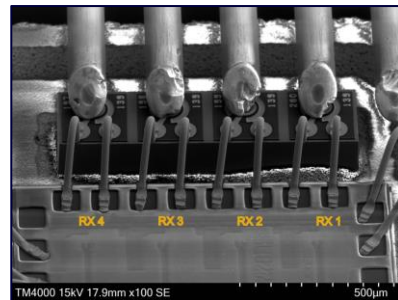
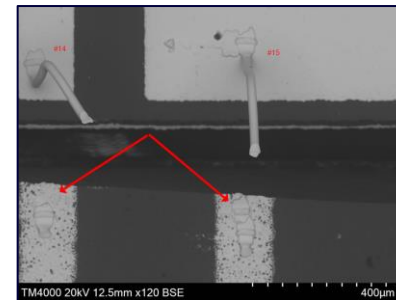
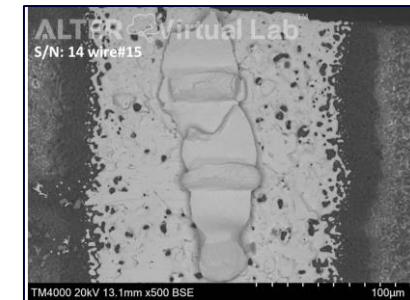
- The same observation as in the visual inspection were confirmed during SEM inspection. Additionally, one of the samples showed damage at the end of the optical fiber located at the RX diode. This sample was one failing in Group 2. However, no correlation is found between this deviation and the failure.
- Two samples passed wire pull test on all wires, while one wire failed in the third tested sample, failing at neckdown point.
- SEM inspection showed a rebonding in the failed wire bond pad, being the only bonding pad showing a rebonding.

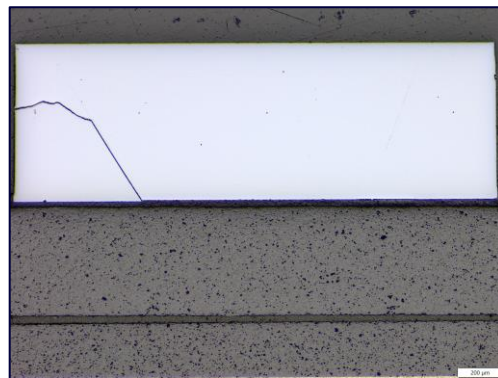
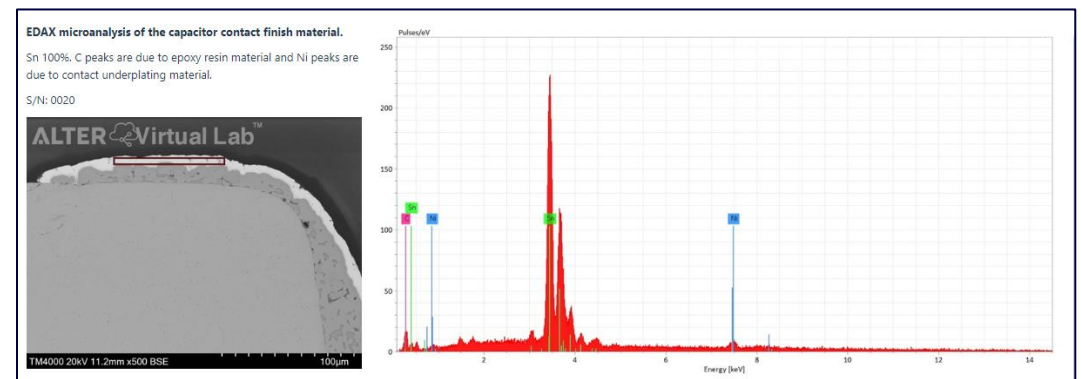
- During die shear all elements were sheared with a force greater than the minimum, even if lack of die attach material was observed before.
- Microsection inspection showed an unacceptable crack in the die (TIA).
- Material analysis showed the same deviation as the one observed during the constructional analysis, pure tin in the capacitors contact finish
