Project **MAGNIFIED** – Final Presentation

ESTEC – Noordwijk, Netherlands

27 September 2023

FOTEC Forschungs- und Technologietransfer GmbH, 2700 Wiener Neustadt, Austria

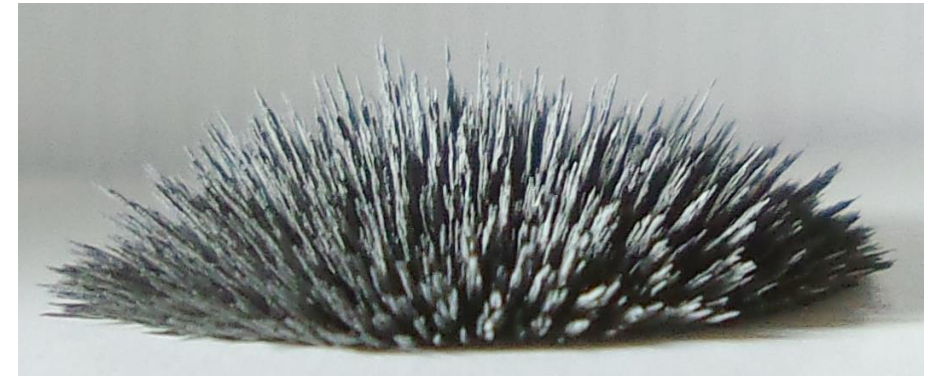
Example of magnetically shaped array of spikes

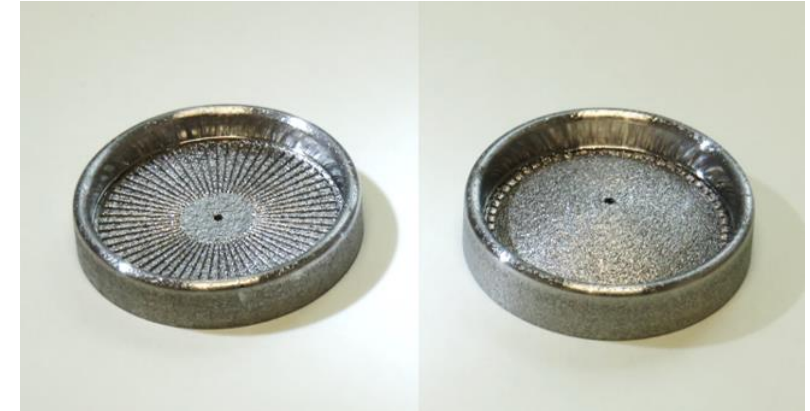
- The process started with the manufacturing of titanium and stainless-steel **bases**, which were then used as support structures for the creation of the spikes
- After the creation of the spikes using iron powder and magnetic fields, the emitter went through the next steps of sintering and wetting
- **36 emitters have been manufactured**, with different needle array densities and shapes
- Of these, **28 have been wetted with the propellant**, consisting in a eutectic alloy of gallium and indium, which is liquid at ambient temperature

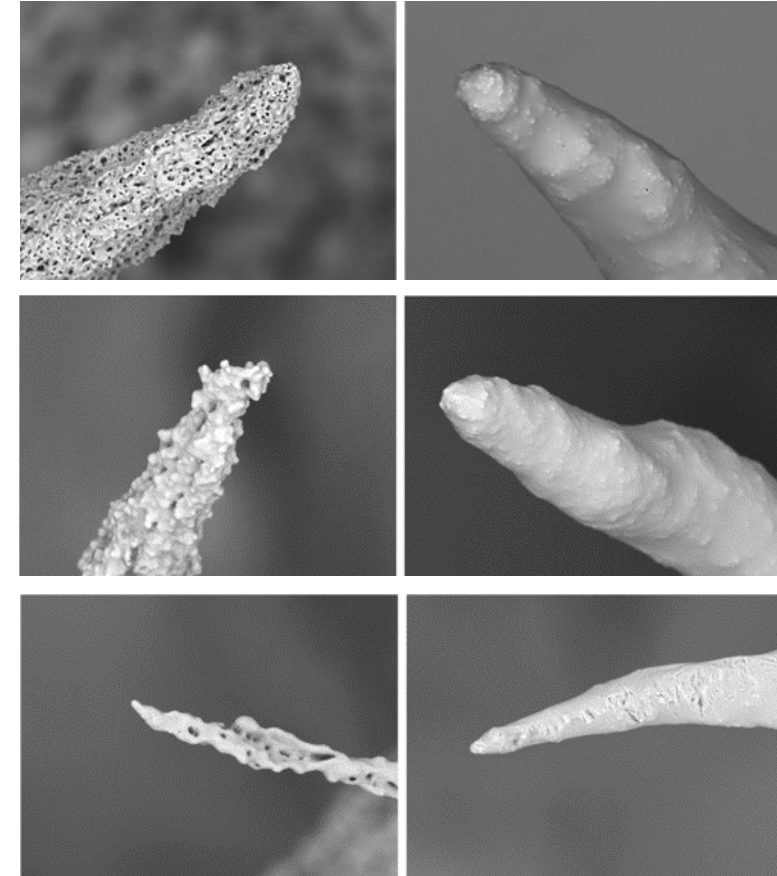
Tips before (left) and after (right) wetting

- Measured tip radii ranging from **1.5 to 25 μm**
- Most of the emitters were fabricated as **2D arrays** of spikes, that is, spikes distributed over a two-dimensional surface
- The 2D arrays could be roughly grouped into three categories depending on the **density of the spikes**: low, high, and medium density, corresponding respectively to approximately 50, 100 and 200 spikes per square centimeter
- The exception was a crown-like emitter, constituted by 40 spikes arranged on a closed circular path (1D array).

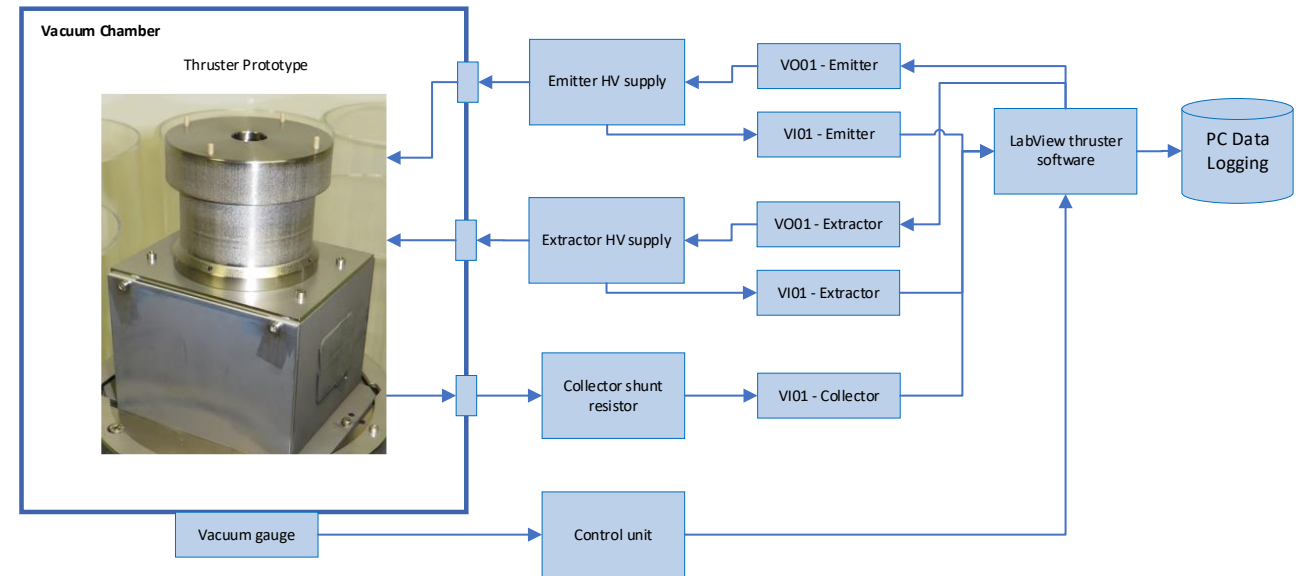
- The **power to emitter** was provided by a Matsusada AU-100R22-LCF (0-100 kV / 0-22 mA, limited to 20 kV/20 mA)
- The **power to extractor** was provided by a Heinzinger PNC 20000-10 (0-20 kV / 0-10 mA)
- All the data from the power supplies, the collector and the vacuum gauge was **monitored and recorded by a Labview-based software**
