D6 - Final Presentation

Battery Passivation

Mathilde Aouizerate – Airbus Defence & Space
ESTEC – 23rd October

Battery Safety and Passivation

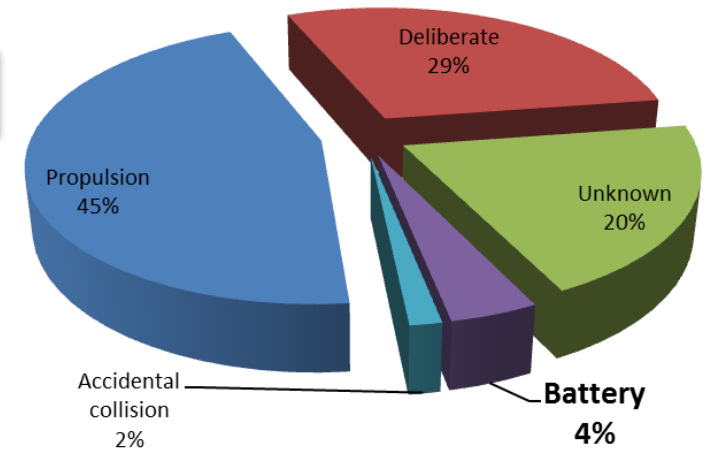
Causes of known satellite breakups until 2008.
Source: US Space Surveillance Network (SSN)

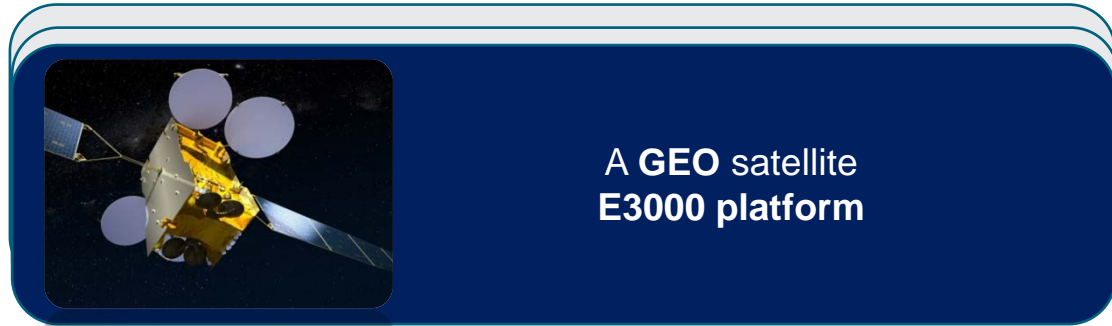
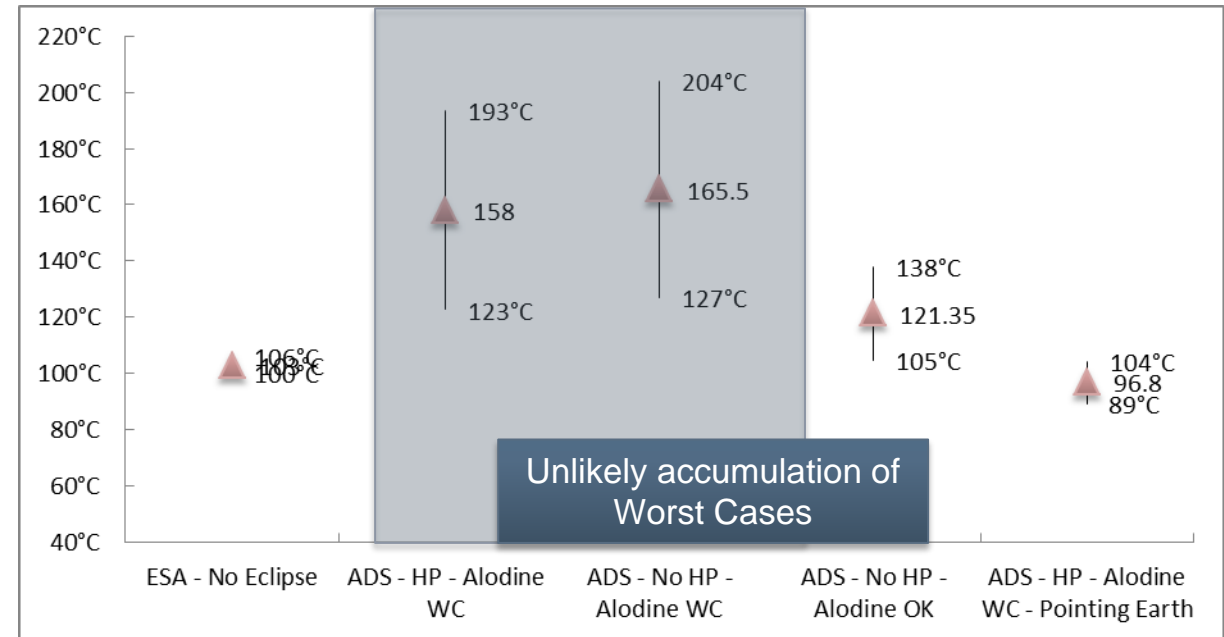
- Orbit: Geo-synchronous orbit
- Duration: 100 years (or forever)
- Season: Solstice (no eclipse) – **certain worst case**
- Attitude: Radiator pointing the Sun – **possible scenario**

- MLI completely torn off – **Unlikely?**
- Absorptivity degraded to 1 - **Possible**
- Heatpipes failure - **Unlikely**
- Internal MLI remains intact - **Likely**

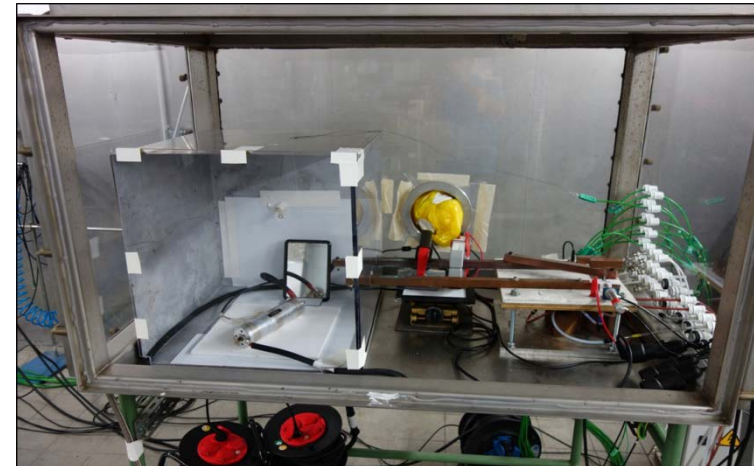
ABSL cells test setup

3 mΩ short-circuit on VES140 Test setup

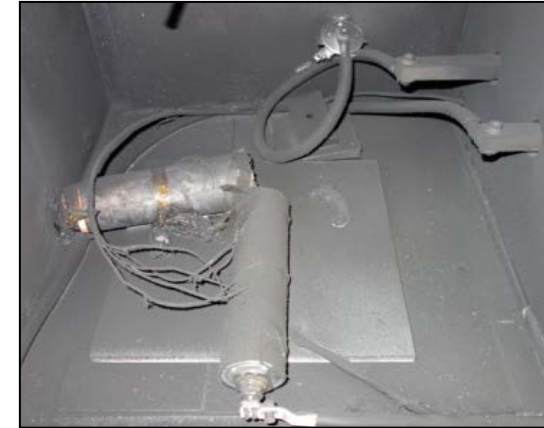
- VES140 & VES180: no internal protections
 - High current spikes (>1000 A)
 - High temperatures (up to 160°C)
 - Ejection of electrolyte and even the jelly roll (**debris generation**).
- VES16:
 - Circuit Breaker activation
 - Electrolyte leakage and smoke but **no debris generation**

3 mΩ short-circuit on VES140

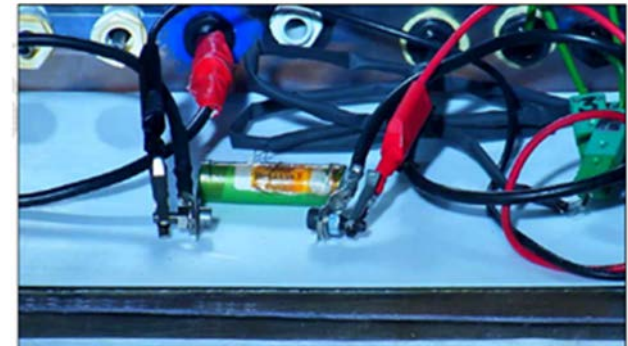
- PTC (internal protection) is activated for all cells, limiting the temperature rise (85°C)
- No ejection of electrolyte or smoke. **No debris generation.**

100 mΩ short-circuit on HCM cell

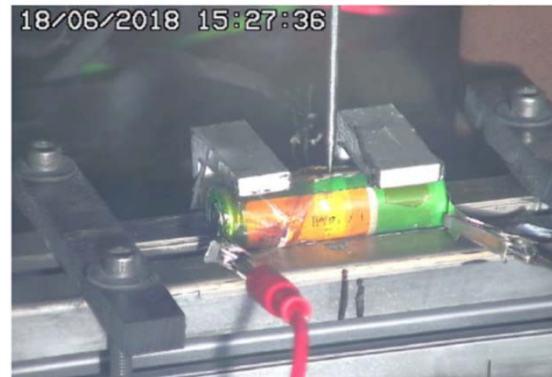
VES140 Test setup

ABSL cells test setup

Impact of nail location and penetration depth was assessed

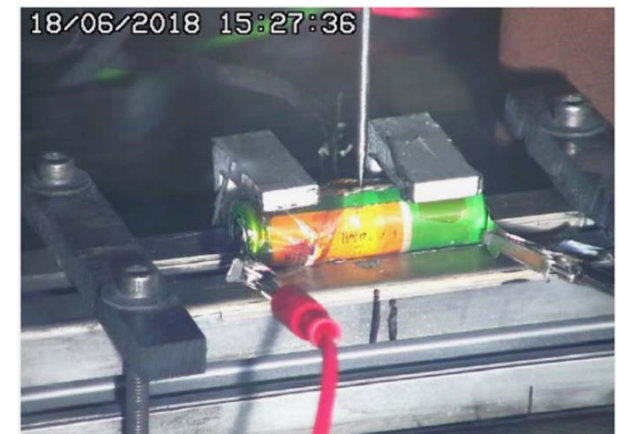
Nail test on a
HC cell
Release of smoke

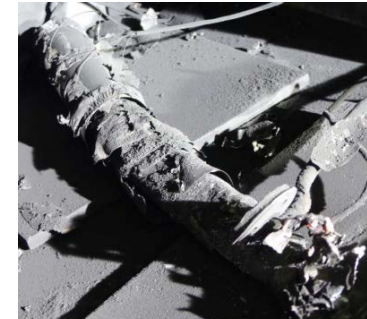
- VES140 & VES180: no internal protections
 - Exothermic reaction (up to 990°C), opening of the cell
 - Flames, jelly roll ejection sometimes(**debris generation**).

VES140 cell after overcharge at 1C

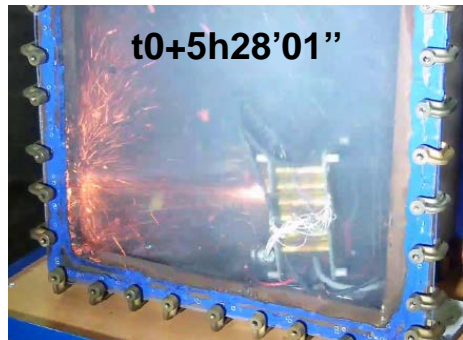
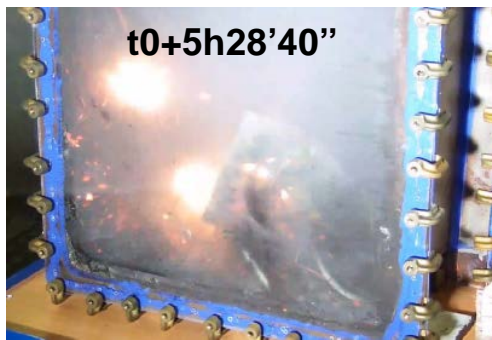
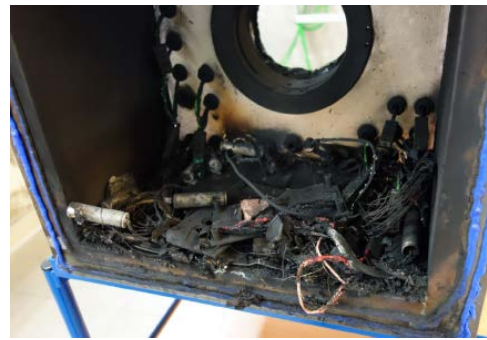
- **Overcharge at 1.5C (7.2A)**
124°C
Activation of the CID, limiting temperature rise

- **Overcharge at C/3 (1.6A) - 1333°C**
Activation of the CID on 1 string only

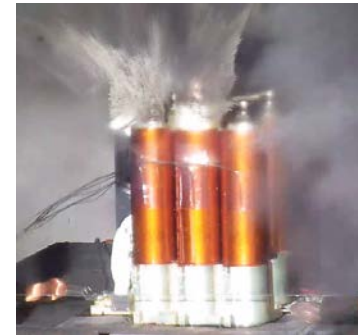
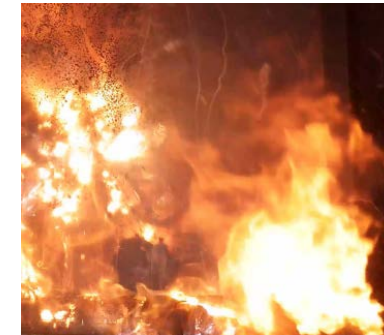
SAFT Modules :

Overcharge at C/8 (40A)
950°C

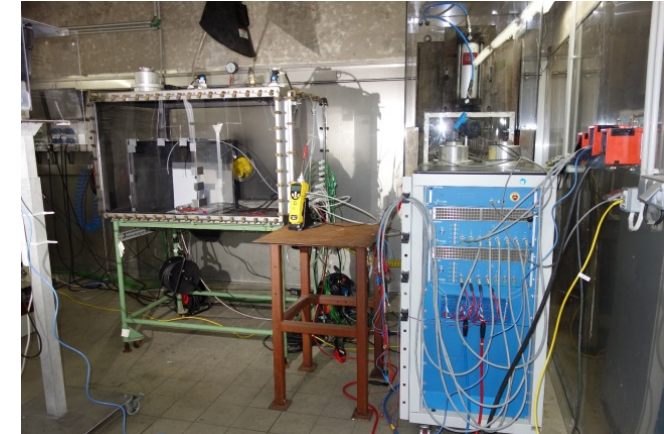
VES140 cells - Test setup
