DESIGN FOR DEMISE BREADBOARDING – MLI CCN

FINAL PRESENTATION

25.03.2022

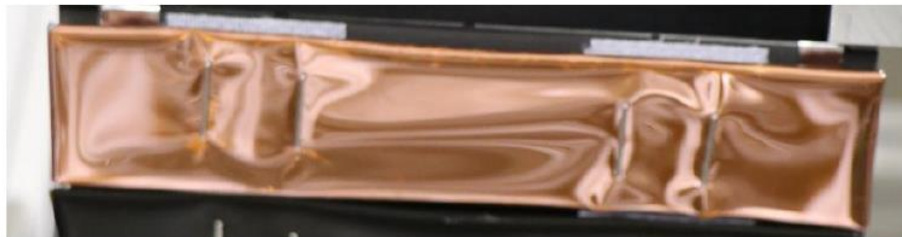
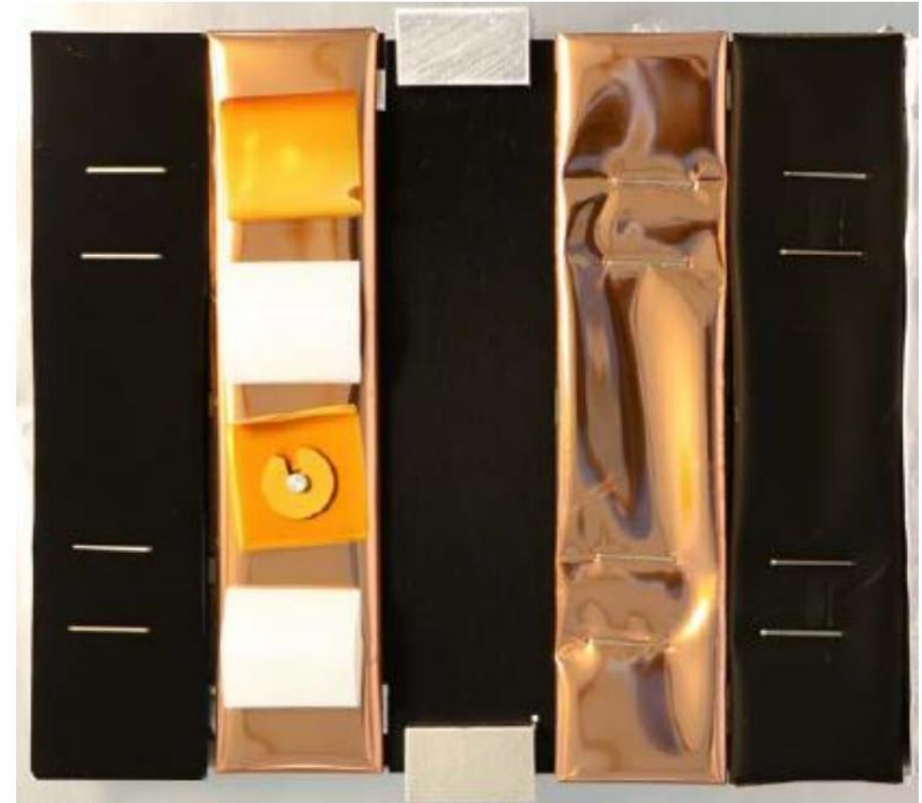
TEST RESULTS – ATOX

- Use Full Fluence
 - Variation across samples ($1.36e21$ to $2.78e21$ / cm^2)
- Observations
 - Darkening of Kapton Black, CFRP
 - Erosion of Kapton loops
 - Some MLI damage around staples
 - Very minor impact

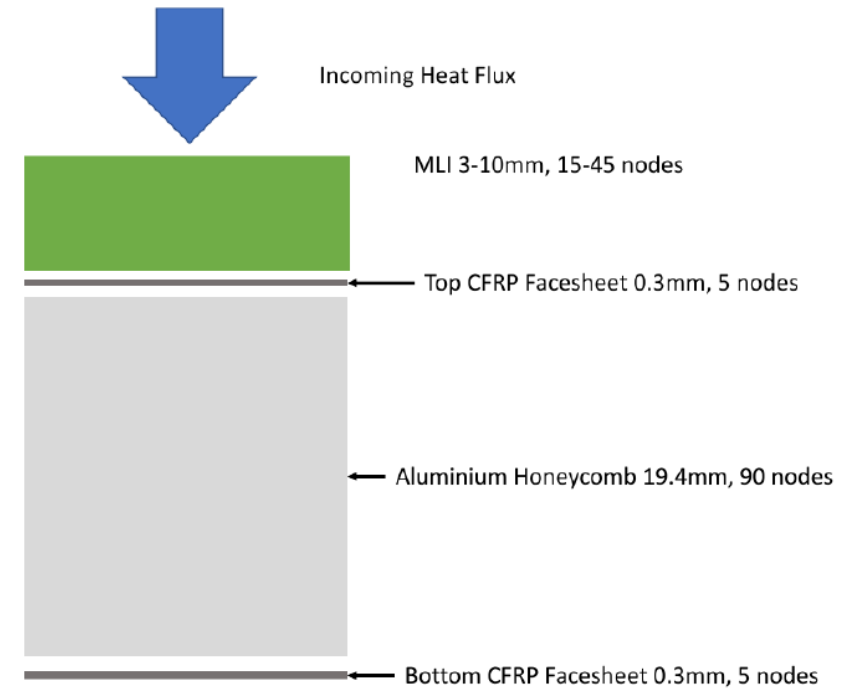
TEST RESULTS AND ANALYSIS – DEMISE

- SAMj Model - 1D layup used
 - Different layup with MLI present
 - MLI conductivity fit to data (consistent)

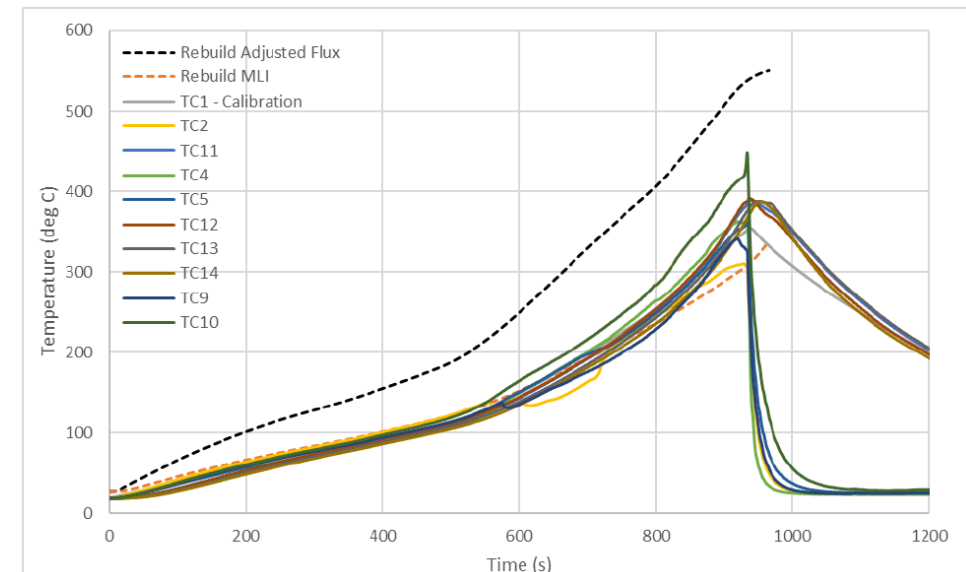
TEST RESULTS AND ANALYSIS – DEMISE

- Alternative MLI Materials (Kapton Black) with Standoffs
 - Slightly less insulation effect
 - Baseline model (left), adjusted model (right)
 - Same temperature thresholds for warping, frontsheet release
 - Standoffs are not removed – released with frontsheet

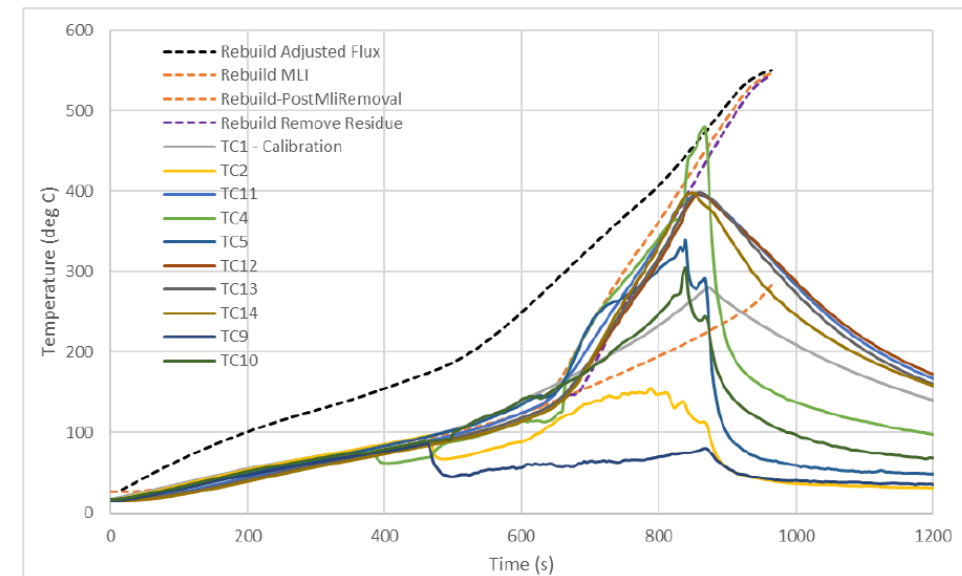
TEST RESULTS AND ANALYSIS – DEMISE

- Baseline MLI with Velcro

- Same MLI insulation model – consistent behaviour
- Much earlier release of MLI, Velcro melt <math><150^{\circ}\text{C}</math>
- CFRP Frontsheet remains in place, removed at - Again, model captures heat rise after removal

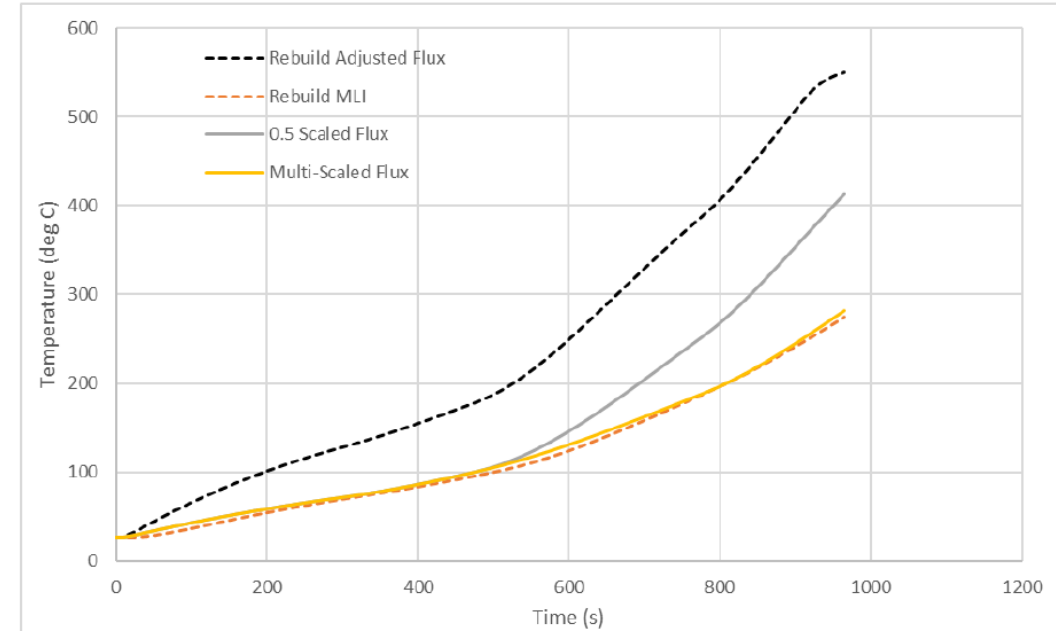
FLIGHT EXTRAPOLATION

- Proxy Scale for Input Heat Flux

- Models for MLI removal
- Velcro
 - Fail at 150°C
- Standoffs
 - Warping at 200°C

- Increased flux

- Removal at 350°C

- Bulk Heating Model

- Verified on test data
- Applicable to flight

Heat Flux (kW/m ²) Nominal	Heat Flux (kW/m ²) Calibrated	Scale Factor
<5000	<3500	0.5
5000	3500	0.5
20000	14000	0.27
50000	35000	0.23
