Author Lena Thorsson, lena.thorsson@exmet.se
	Date of issue 2019-12-20
Exmet AB c/o Swerim PO Box 7047, S-164 07 Kista Sweden	Project Manufacturing of Metallic Glasses for Bearing Applications ESA Contract No 4000123990/18/NL/LvH/zk
	Document Title Executive Summary – Open version

1.2 Technical background and Objectives of this activity

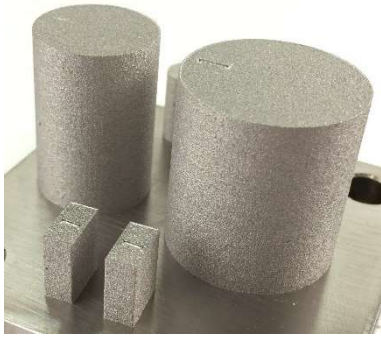
Figure 1. ESA1 LTH255.

When “best” laser parameters had been determined, samples intended for evaluation and the hardware delivery samples HW2 were built (shown in Figure 1 - Figure 3).

Comparing the exterior appearances, it was determined that the ESA1 samples looked best; showing a consistent and matte surface for both cylindrical and square samples, without visible edge cracks that were especially apparent on the square corners of ESA2 and ESA3 samples.
