# S I S T E M

# SMALL INFLATABLE SPACE TANKS

# ENGINEERING MODEL

FINAL REVIEW (FR)

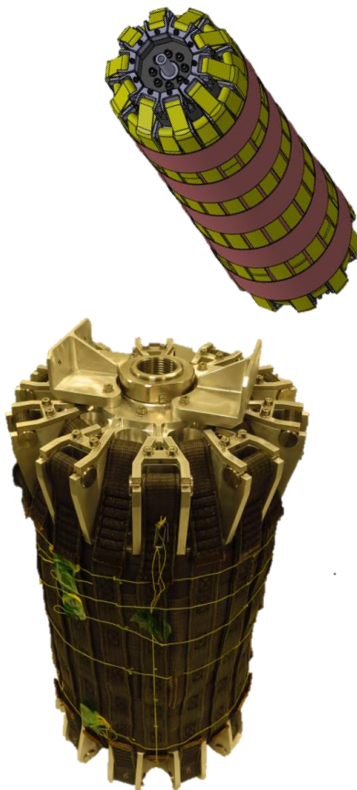
The technical solutions is based on a **12 liters tank prototype** to fly in compacted configuration and then used on-orbit for high pressure storage of gases or cryogenic fluids or water/urine.

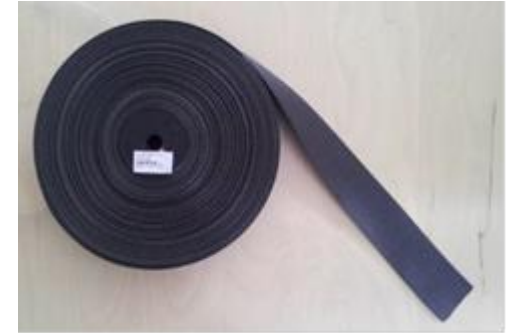
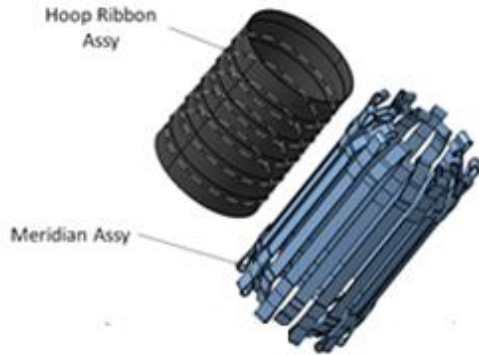
Hoop and meridian belts based on PBO (Zylon®) treated with FKM-Viton, showed a mechanical performance capability of 55000 N.

At beginning two different ribbons have been evaluated :

- one for the hoop assy based on already qualified belts ( Cygnus program)
  - Width = 49,5 mm
  - Thickness = 1,0 mm
  - Mass = 38 g/m
- and one developed at hoc

/// Test campaign on basic ribbon materials highlighted a linear behavior and a good standard deviation of tested specimens, the failure mode is the webbing rupture.

/// Effect of defects (transverse cut of 24.5 mm) is about 40% of the load capability and a slight reduction (about 10%) takes place on samples after irradiation, confirming the excellent effectiveness of Viton as protective coating for PBO-based ribbon.

/// The meridian new configuration (  $w=25.4$  mm) showed good performance in terms of linearity and rupture mode and finally the load capability is up to 85% of the hoop basic ones

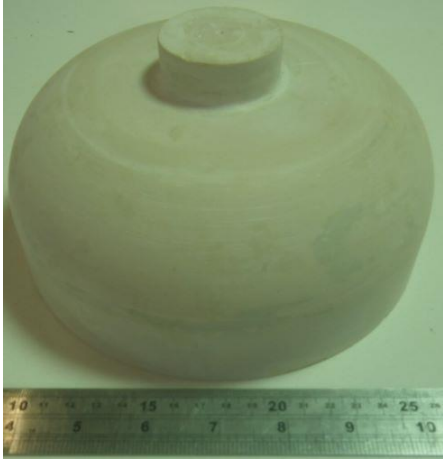
Mould tool for open end

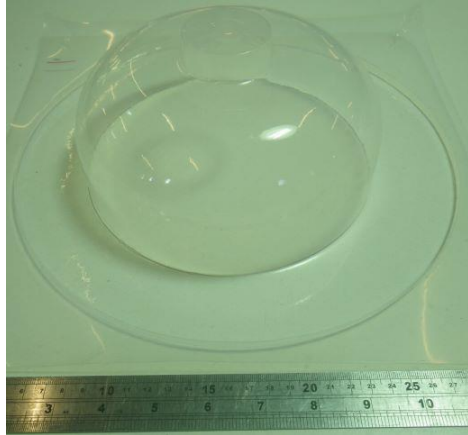
Vacuum formed endcap for open end  
(before trimming to size)

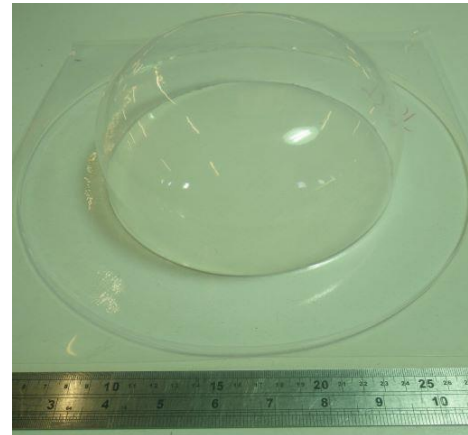
Vacuum formed endcap for closed end  
(before trimming to size)

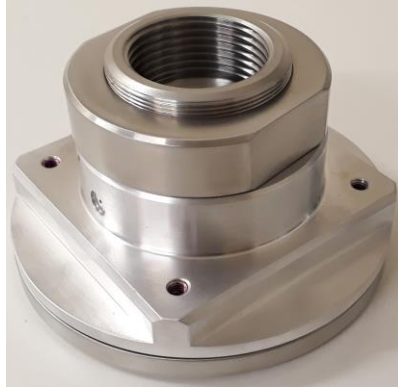
Top profile

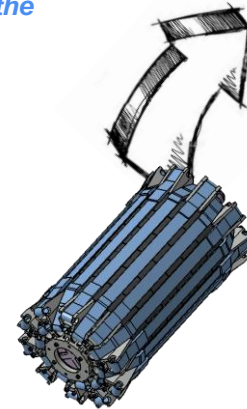
**Step 6**  
Intergation in TAS of  
lower dome

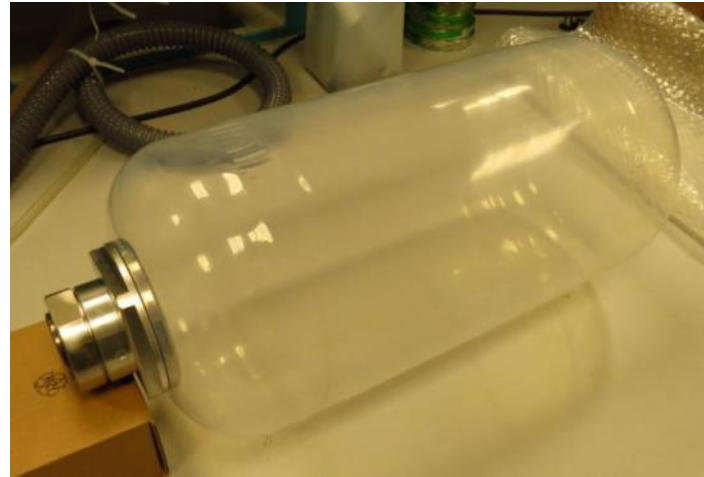
1. Bladder discontinuity highlighted and marked

1. Use as is

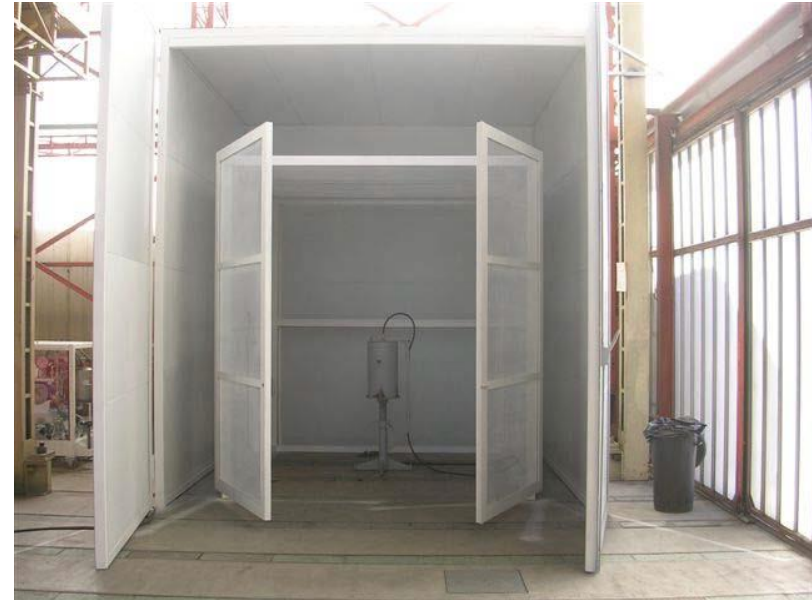
Every test concerning the pressurization of the tank will be performed inside a dedicated test building that meets the safety requirements about such kind of tests. Inside this building a safety box, having enough room to accommodate the hoisting fixture with the tank, has been realized.

This building is provided by the following utilities: electrical power source 220 V single phase and 380 V three phase; pressurized service air; air heating plant. This area has an external safety wall composed by concrete blocks.

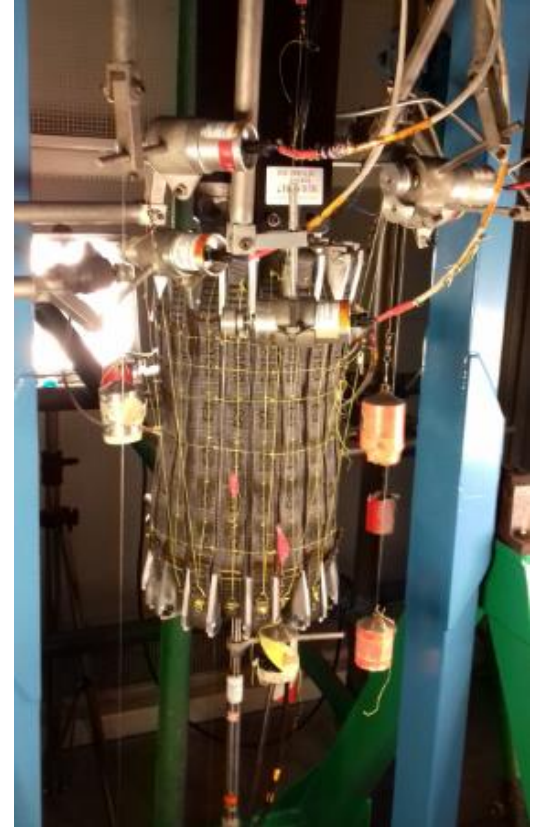
The test has been stopped soon due to the leakage appeared at few bars ( $1\text{bar} < P_{\text{test}} < 2\text{bar}$ ) .

The leakage area has been marked (see the movie) and the tank has been disassembled in order to evaluate the problem.

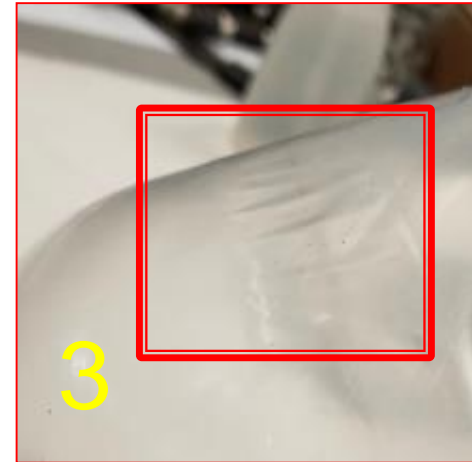
Fissures appeared on the areas marked during the acceptance inspection, in particular the damage n°1&2, which are pass through crack. The n.3 instead seems to be not affected by the pressure test.

Upper dome zone  
welding line area

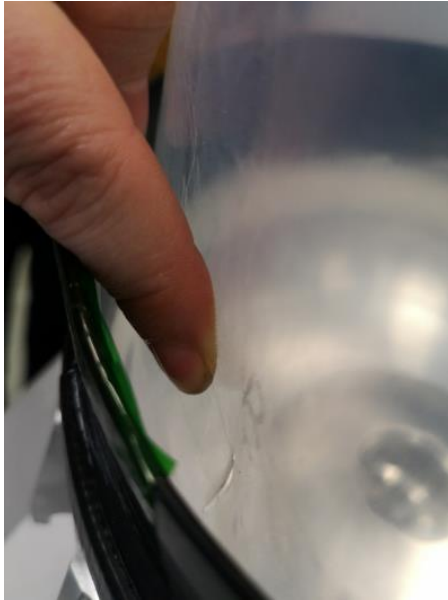
Upper dome  
portion

After the test, in order to verify the leak areas it has been needed to disassembling of the tank assy. After that, the following majors flaws have been detected on the bladder:

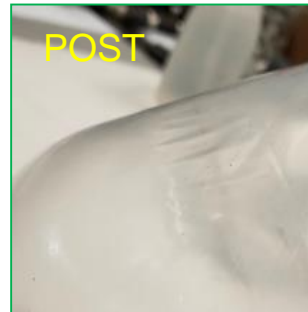
no changes pre and post

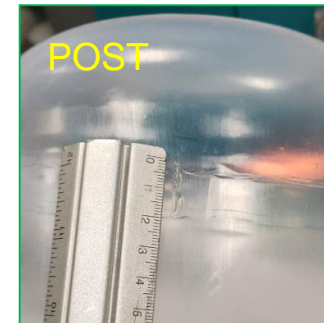
change pre and post

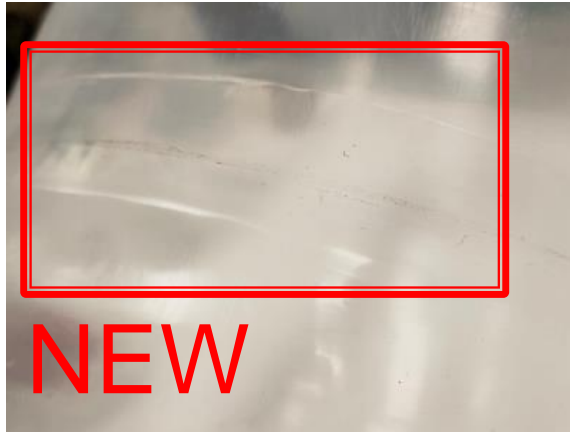
A deeper examination after full disassembly, showed new discontinuities (details on L and R images):

Upper dome zone  
welding line area

→ Repair process ( assessed at sample level) application to bladder model to be evaluated by HOLSCOT

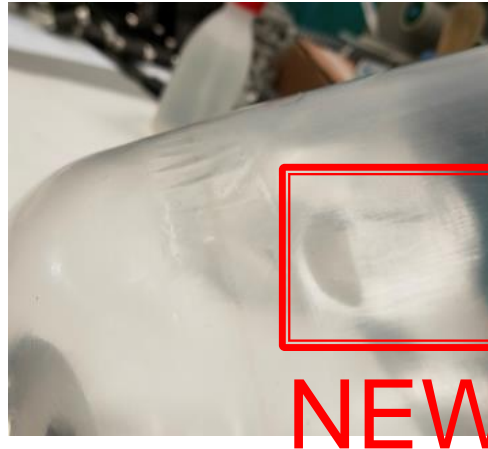
Upper dome area  
(created during the  
tank disassembling)

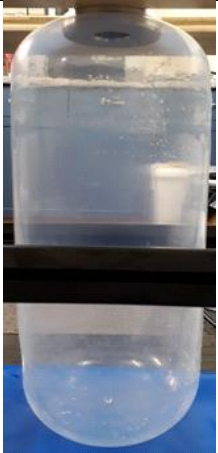
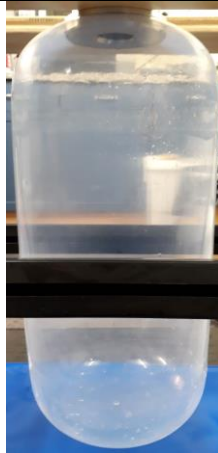
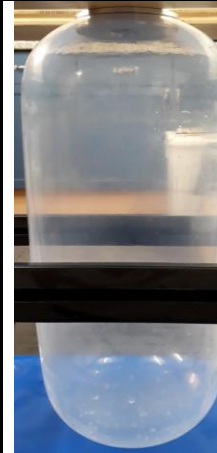
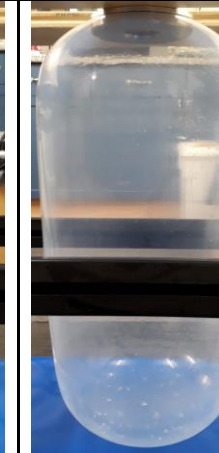
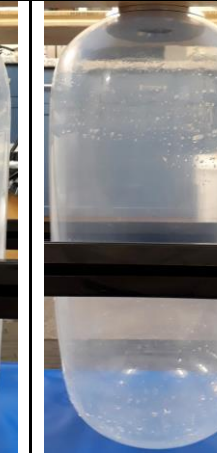
Internal pressure/bar	0.0	0.4	0.6	0.8	1.0
Diameter of bladder at centre line/mm	198	200	202	204	208
Distance between centre of welds/mm	252	252	254	254	252
Image during test

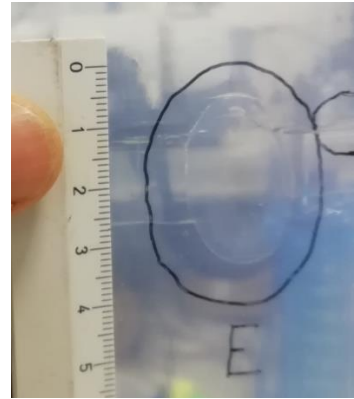
Discontinuity <5cm

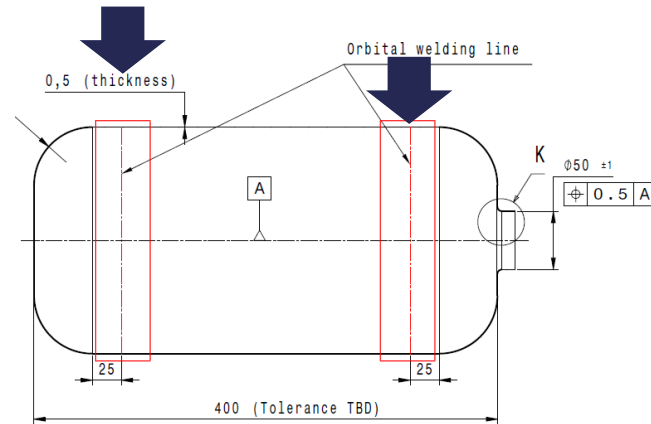
*Transition zone mitigation:* The bladder inspection put in evidence that the area affected by the Welding repair is larger than expected, in fact it is not limited to an orbital line (red dot lines) but it shall be considered a large band (red areas).

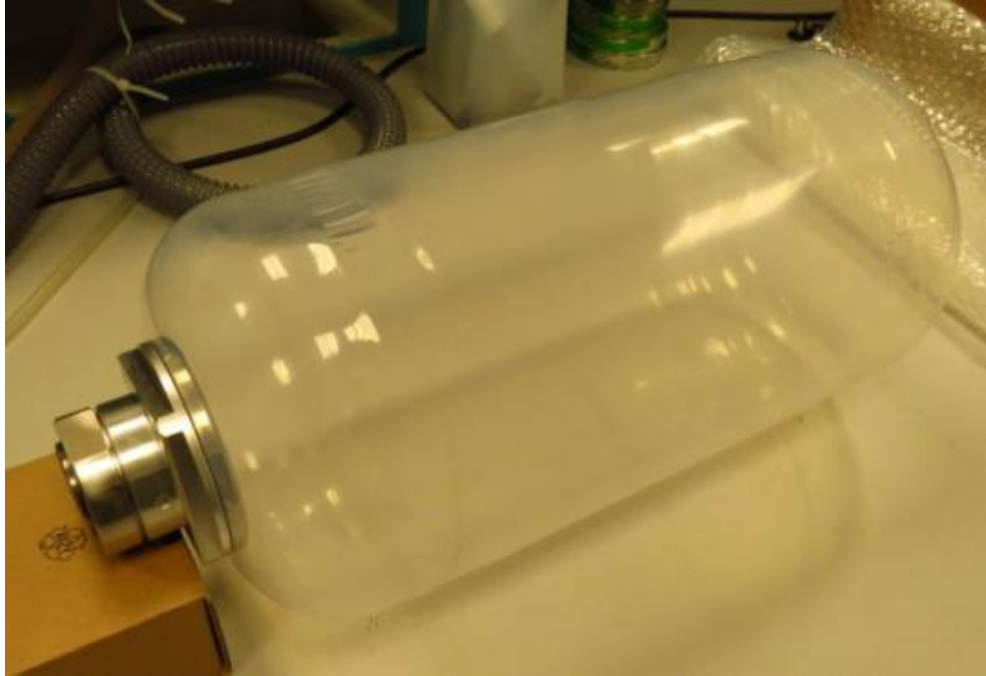
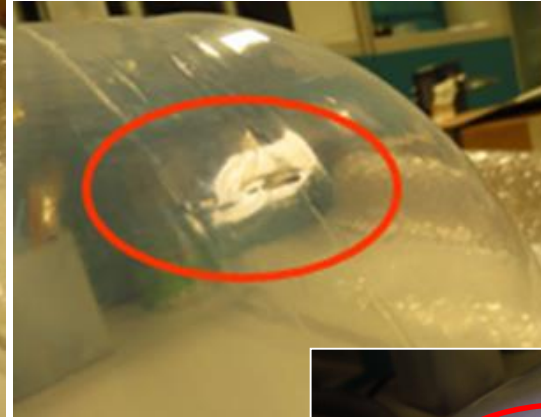
As you remember, at the beginning of test campaign, on the liner of test article, several discontinuity, on circumferential welding, were highlighted and marked.

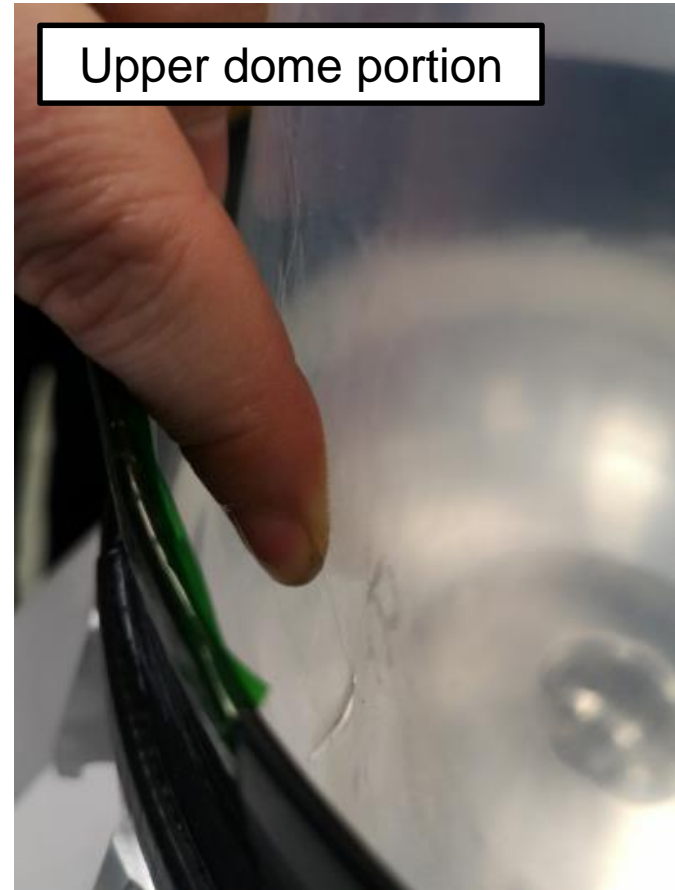
- Pressure (N2) level reached  $\leq 1$  barg
- The test set-up was disassembled and the visual inspection on the demated test article put in evidence that the majors flaws have been detected on the bladder (Upper dome portion), in an area (called R) already detected as critical.
- The Bladder was sent to the manufacturer for the repair

1. The Bladder was sent to the manufacturer for the reparation,
2. After liner, return back, a silicon based filler (Shore 15) has been casted into the gap between the bladder and Metallic domes in order to recover any gap between bladder and dome.

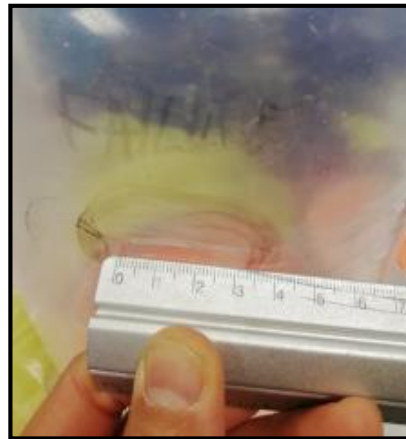
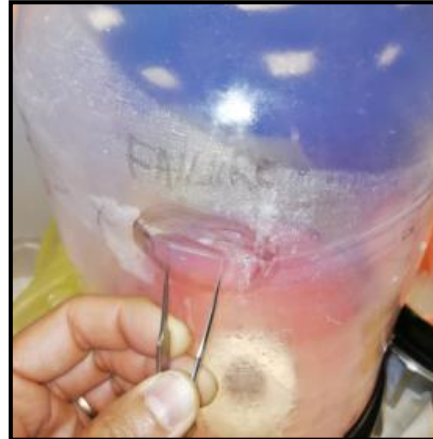
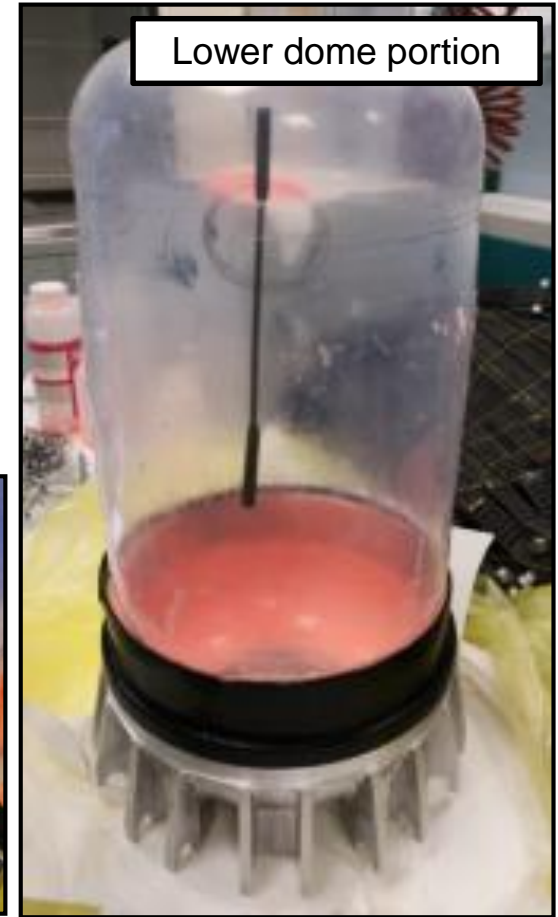
- Pressure (N2) level reached  $\leq 2$  barg
- The test set-up was disassembled and the visual inspection on the demated test article put in evidence a failure (2cm about) in correspondence of the lower dome welding line (between discontinuity G & E).

1. The Bladder was repaired by (air thigh) simple tape
2. The test will be performed in water in order to reduce, as minimum, the leak de-contribution to the test.

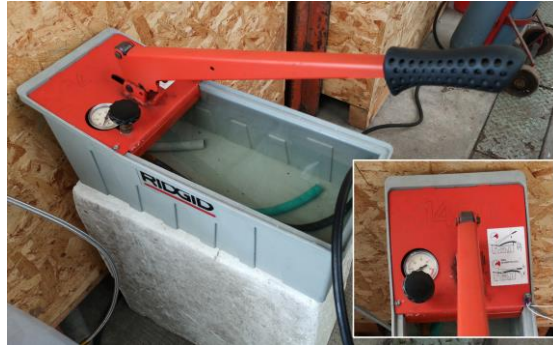
- Pressure (H<sub>2</sub>O) level reached  $\leq 10$  barg
- Even if the leakage still there, a pressure close to 10 bar was reached.  
After that, the pressure was not increased due to the water pump limitation.  
It was, due to its nature (alternative motion), not capable to maintain a constant & continue water flux inside the tank.  
The displacement results, coming from test article, put in evidenced the asymptotic behaviour reached by the pressure system.

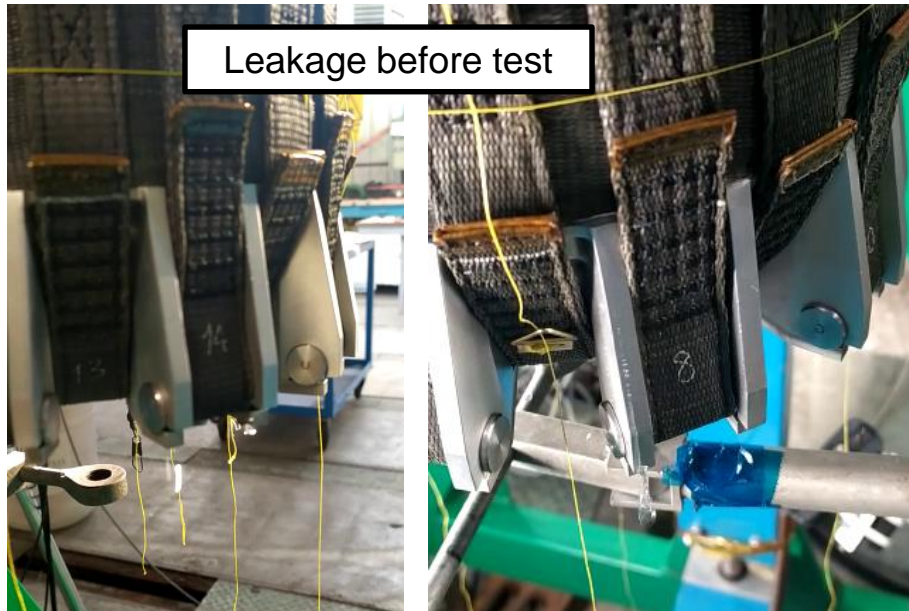
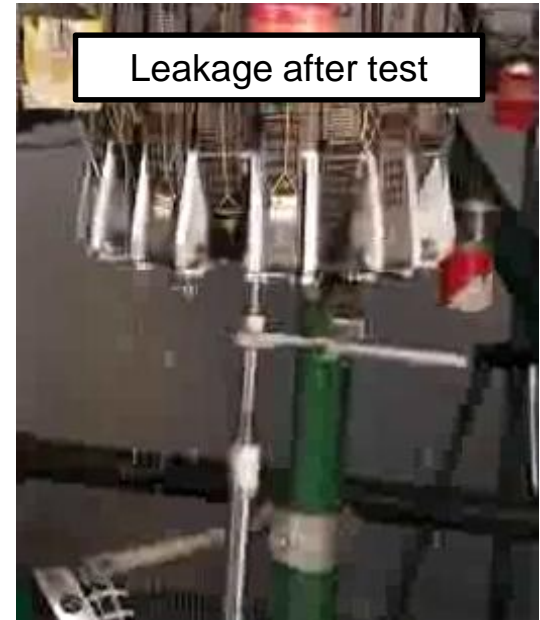
A further result, coming from visual inspection of the water leak (detected much more than beginning ), it is evident a crack propagation.

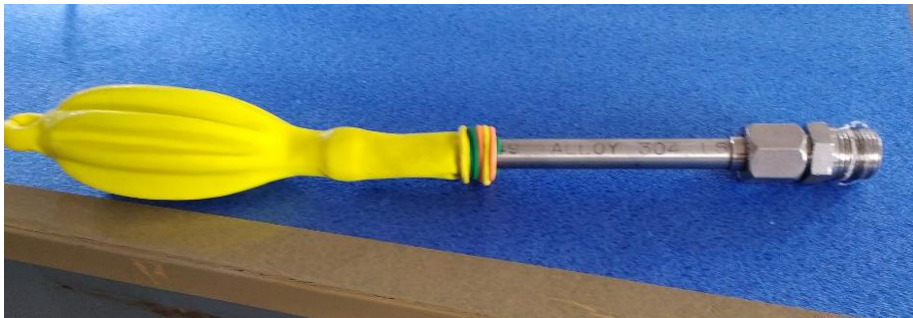
At the beginning, the leakage seems to be solved, but at pressure, close to 2 bar, the balloons were broken and the water was pull out from the upper interface.

Considering what emerged from the above verification, with the single balloon, it would seem that the use of encapsulated balloons (to protect the inner most balloon from the bladder defect) was deleterious rather than useful.

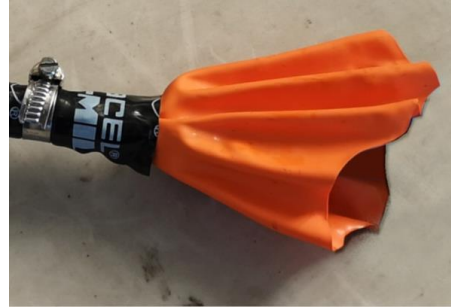
- 1) Balloon filled by Water.  
Broken on neck due to water weight.  
No Test Data available

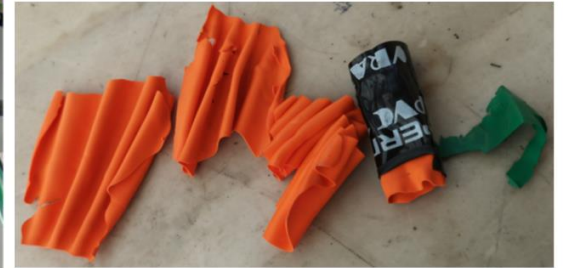
Exploded due to hernia that was arisen, as before, during the push out of inlet from interface area.  
No Test Data available

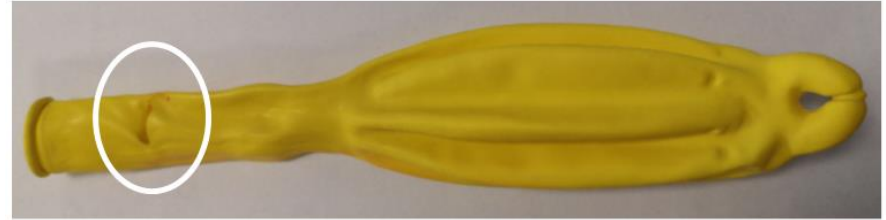
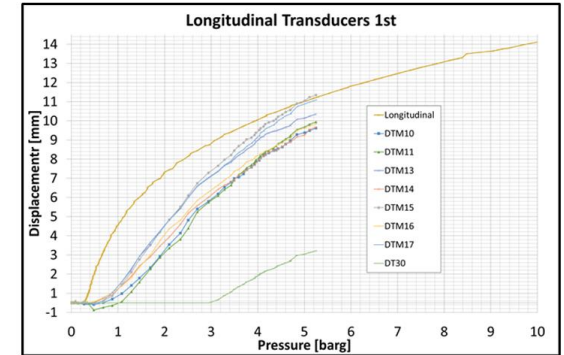
Broken due to a cut on the edge of the hose connector.

Data available up to 5.2 Barg

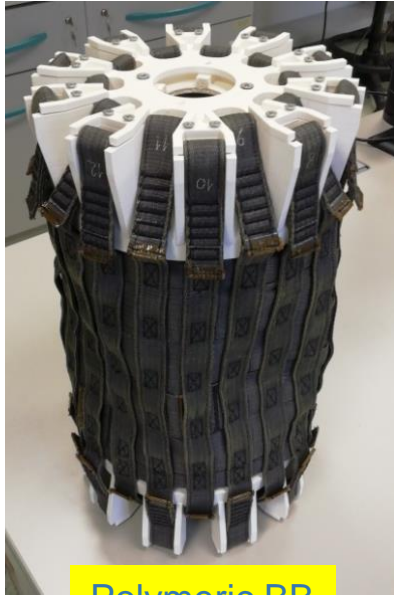
A full scale polymeric breadboard has been realized by TASI in FDM technology, with internal additive manufacturing printer (3NTR SPECTRAL 30), devoted to perform the foldability test campaign in parallel to the metallic EM tank involved in the pressurization test.

Polymeric BB

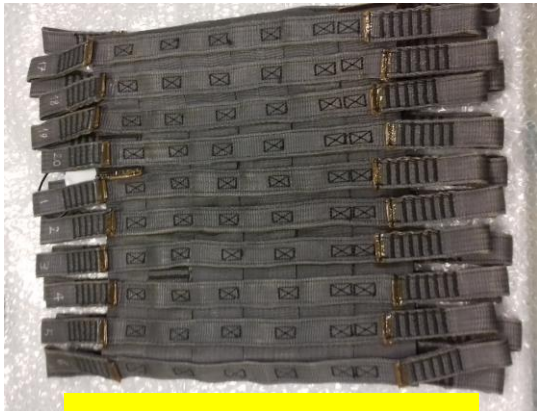
The restraint used is fully similar to the EM restraint in term of dimension and quality, whereas the bladder utilized for this test is a DM bladder characterized by a linear damaging on the welding line as shown in the picture below and it is not equipped with fluidic fitting

SABELT RESTRAINT  
(DM version)

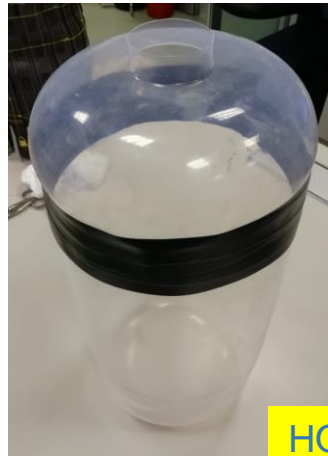
The damaged area has been repaired with tape.

HOLSCOT Bladder  
(prototype version)

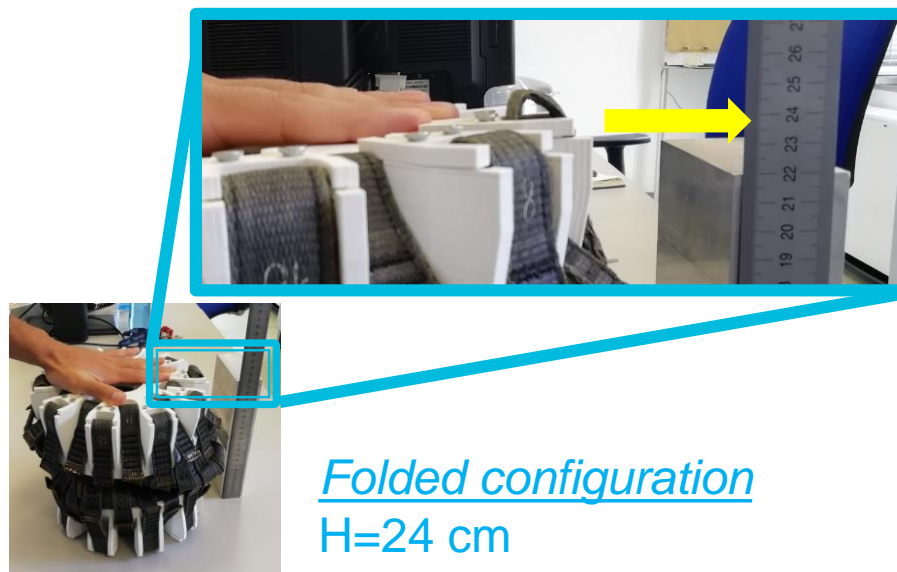
Only one longitudinal folding has been performed with the aim to detect the contribute of the restraint only on the final envelope (H and Ø) in folded and unfolded configuration

$\emptyset_{\text{folded}} = 26\text{cm}$

Packaging longitudinal =44%

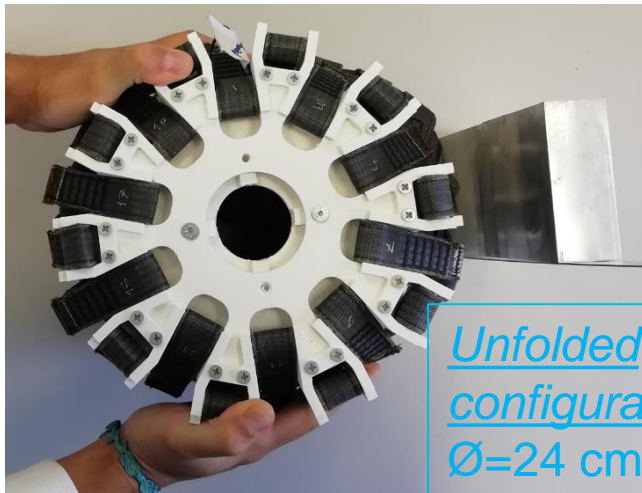
Unfolded configuration  
 $\emptyset=24\text{ cm}$

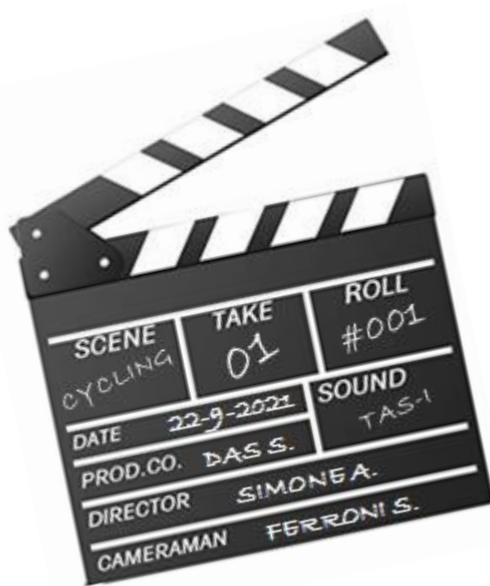
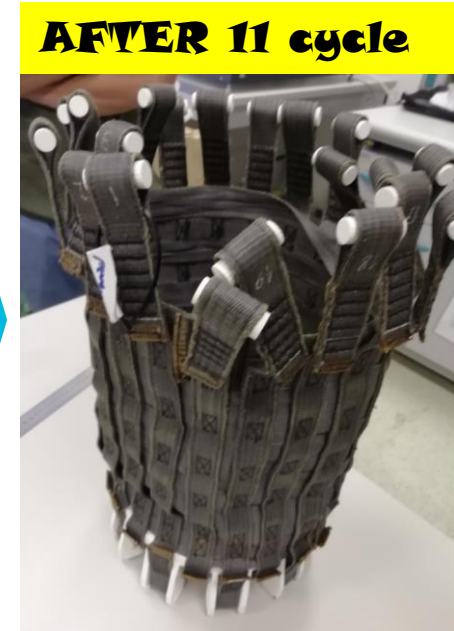
n°10 folding and unfolding in longitudinal direction has been performed to evaluate the effect on the restraint.

No effect on the restraint has been detected after the cycling test.

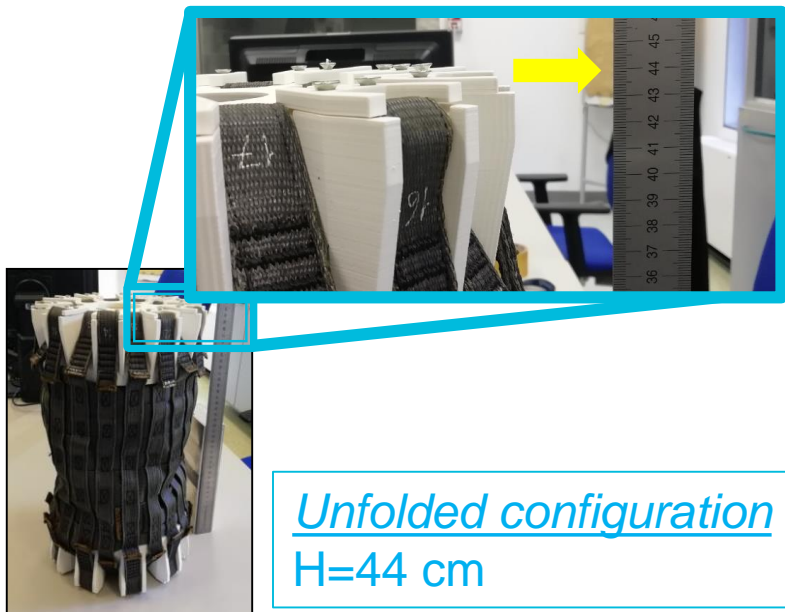
Only one longitudinal folding has been performed with the aim to detect the contribute of the restraint with the bladder inside on the final envelope (H and Ø) in folded and unfolded configuration

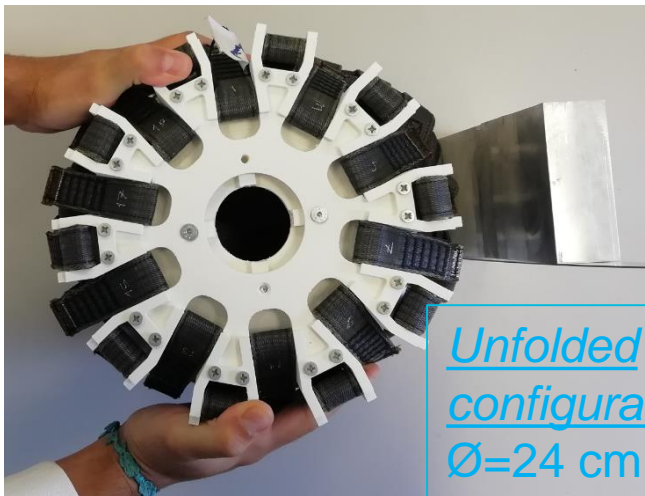
Unfolded configuration  
 $\varnothing=24\text{ cm}$

$\varnothing_{\text{folded}} = 28\text{cm}$

Packaging factor =41%

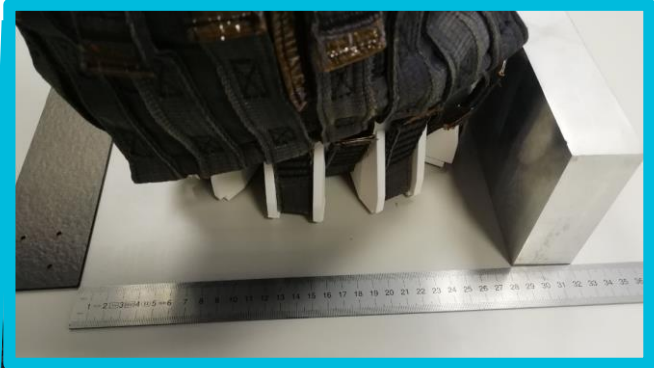
Folded configuration  
 $\varnothing=28\text{ cm}$

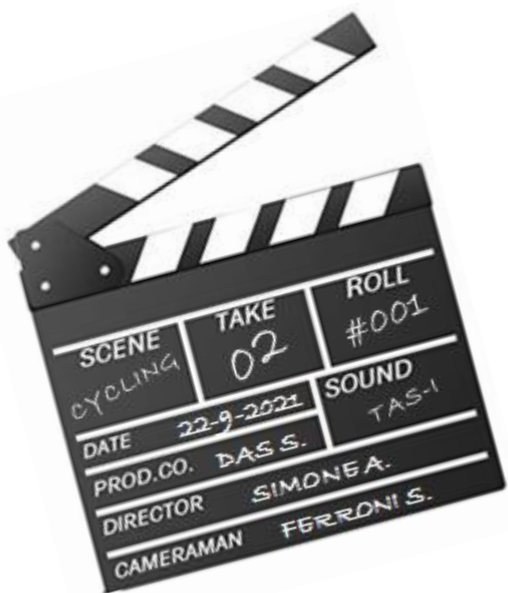
n°10 folding and unfolding in longitudinal direction has been performed to evaluate the effect on the restraint and on the bladder.

No effect on the restraint has been detected after the second cycling test.

After the cycling test any visible findings is detected and the existing crack doesn't increase its extension
