RELIABILITY OF NON-HERMETIC OPTICAL TRANSCEIVERS

Final Presentation

ESA No. 4000133320/20/NL/FE

17th December 2024

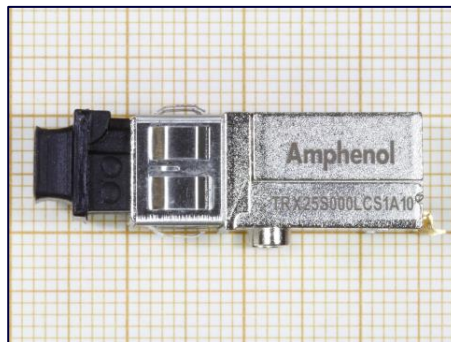
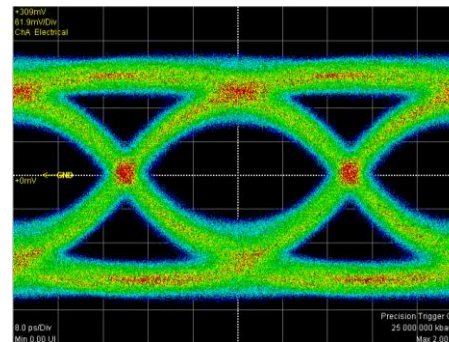
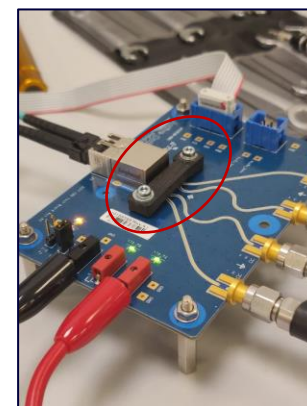
Qty: 34 + 12 extra samples

- A visual inspection and an electro-optical characterization were performed during incoming inspection.
- BER and eye diagram were measured in each characterization step.
- Three samples could not be measured and were sent back to the manufacturer. As replacement, a second batch was delivered with 12 extra samples to be used for Group 4 testing.
- No anomalies were observed during the incoming inspection of the second batch.

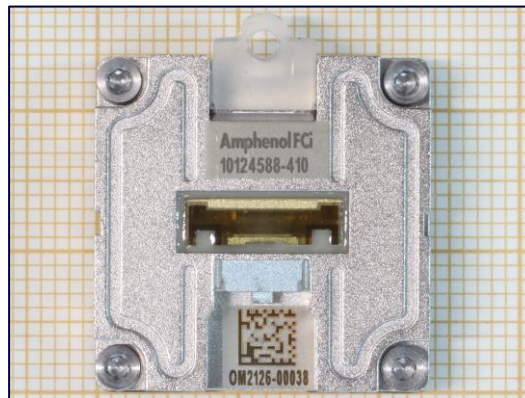
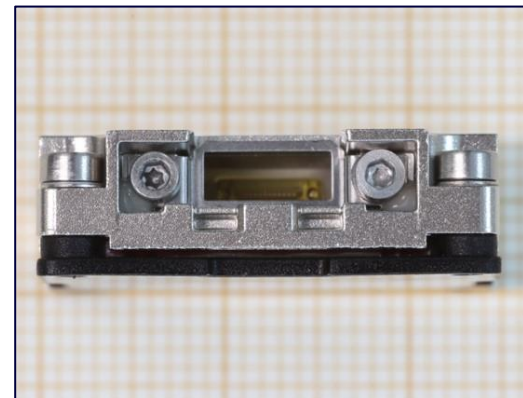
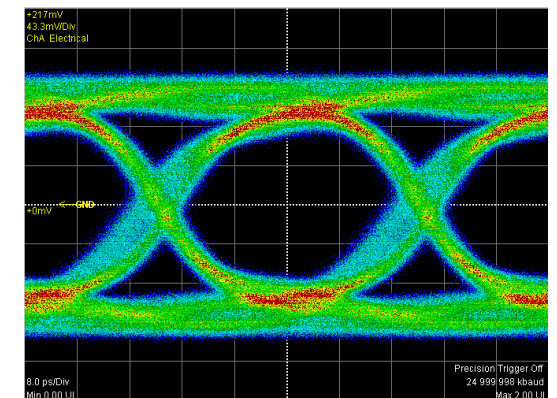
Qty: 34 samples

- A visual inspection and an electro-optical characterization were performed during incoming inspection.
- BER and eye diagram were measured in loopback configuration in each characterization step.
- No anomalies were observed.

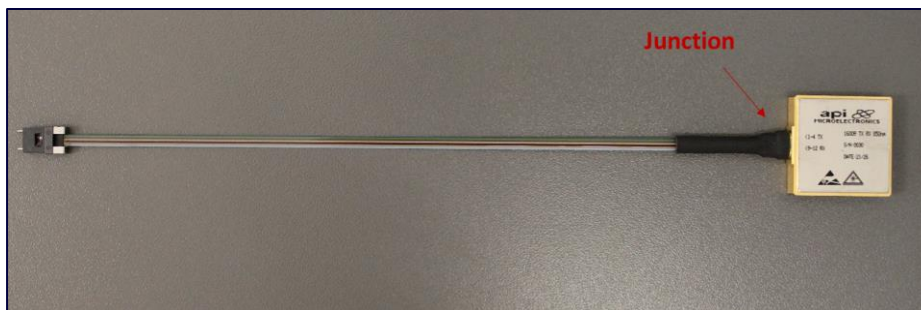
- Repeatability tests were performed on several samples, and it was found that some samples showed no communication error (BER < 10^{-12}), while some others were much more sensitive and not that repeatable.
- It was observed that those showing communication errors were sensitive to the position and movement of the fiber attached on the sample.
- Additionally, since Tx and Rx sides were tested separately, it could be observed that eye diagram on Rx side was closer than Tx side.

Eye diagram on Rx side
